**Service Bulletins
January 1979 to
September 1986 inclusive**

**Rolls-Royce Silver Shadow
Long Wheelbase,
Corniche and Camargue
Bentley T Series and Corniche
Rolls-Royce Silver Shadow II
and Silver Wraith II
Bentley T2**

T.S.D. 4318

ALL ROLLS-ROYCE FRANCHISE HOLDERS
SERVICE BULLETIN INDEX FOR TSD 4318

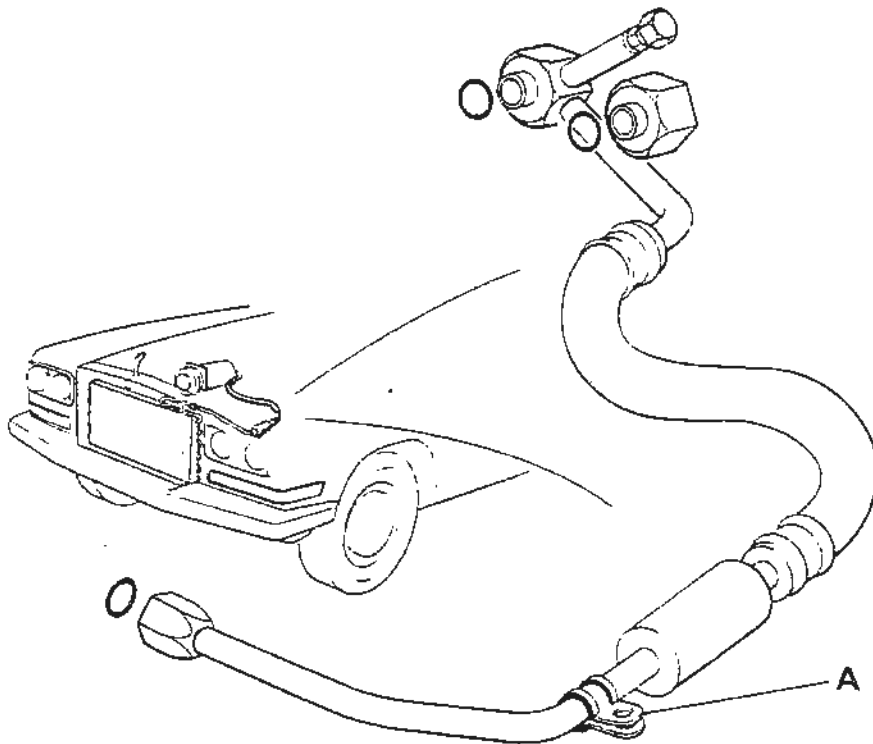
From experience it has been found that the majority of noise originates from the compressor discharge hose. In many cars, a rubber lined clip (UR 14608) in place of the original steel clip will considerably reduce the noise level.

2. Remove the existing discharge hose (UD 20223) complete with 'O' rings and existing metal clip (fitted in position A in Figure 1).
3. Remove the existing 'O' ring from the suction hose, compressor end.
4. Fit a new 'O' ring (CD 4699) to the suction hose compressor end.
5. Fit a new 'O' ring to both ends of the silencer hose assembly. 'O' ring (UD 14799) to be fitted to the condensor matrix connection and 'O' ring (CD 4699) to be fitted to the compressor end.
6. Fit the silencer hose assembly (UD 22704) complete with 'O' rings and rubber lined clip (UR 14608). This clip replaces the metal clip (RE 14174) positioned at point A in Figure 1.
7. Charge the refrigeration system as instructed in TSD 4200 Workshop Manual - Chapter C - Section C2.

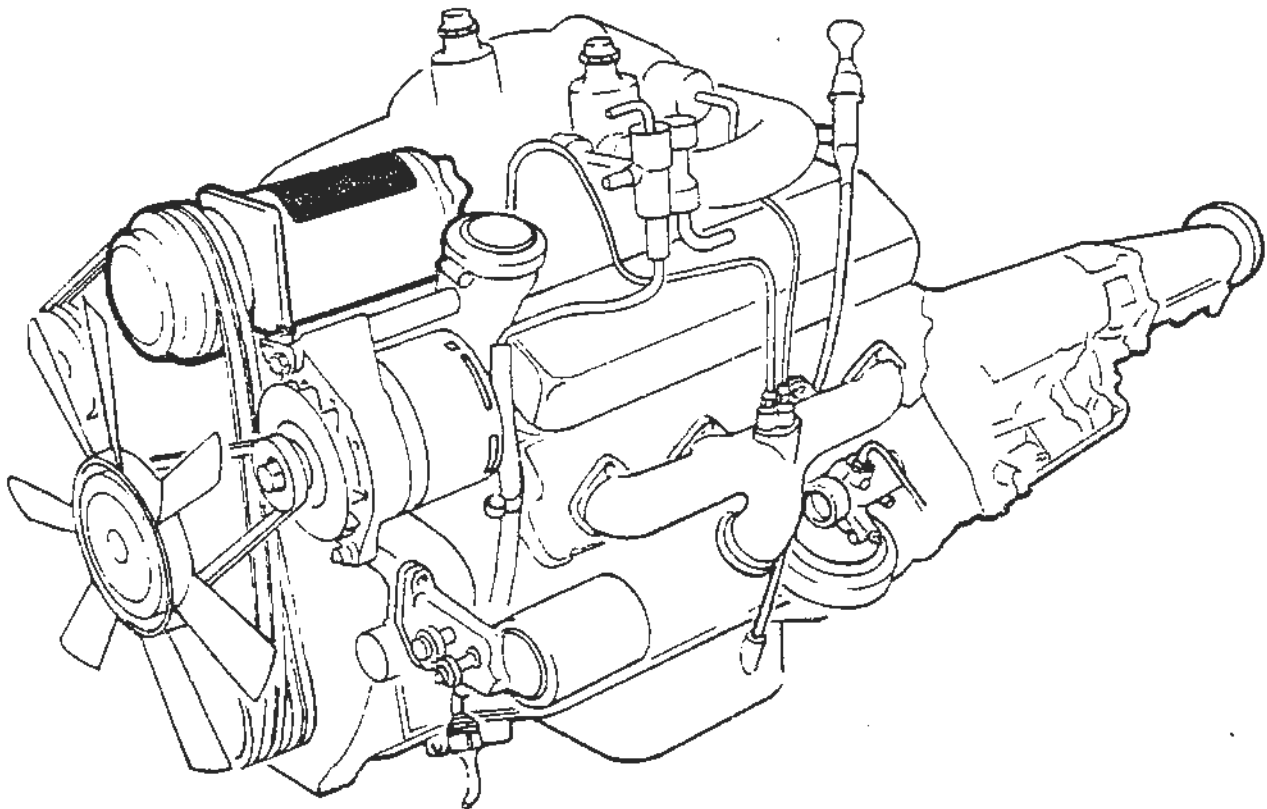
When replacement part stocks of the imperial mounted compressor (UE 40547) are exhausted, the metric mounted compressor (UE 43228) will be supplied for future replacement. The metric mounted compressor can be identified by a label that is attached to the top of the compressor. On later metric compressors this label is bilingual (English and French); see figure 1.

Removal and refitting procedure for the metric air conditioning compressor is exactly the same as for its predecessor. See Workshop Manual T.S.D. 4200 - Chapter C.

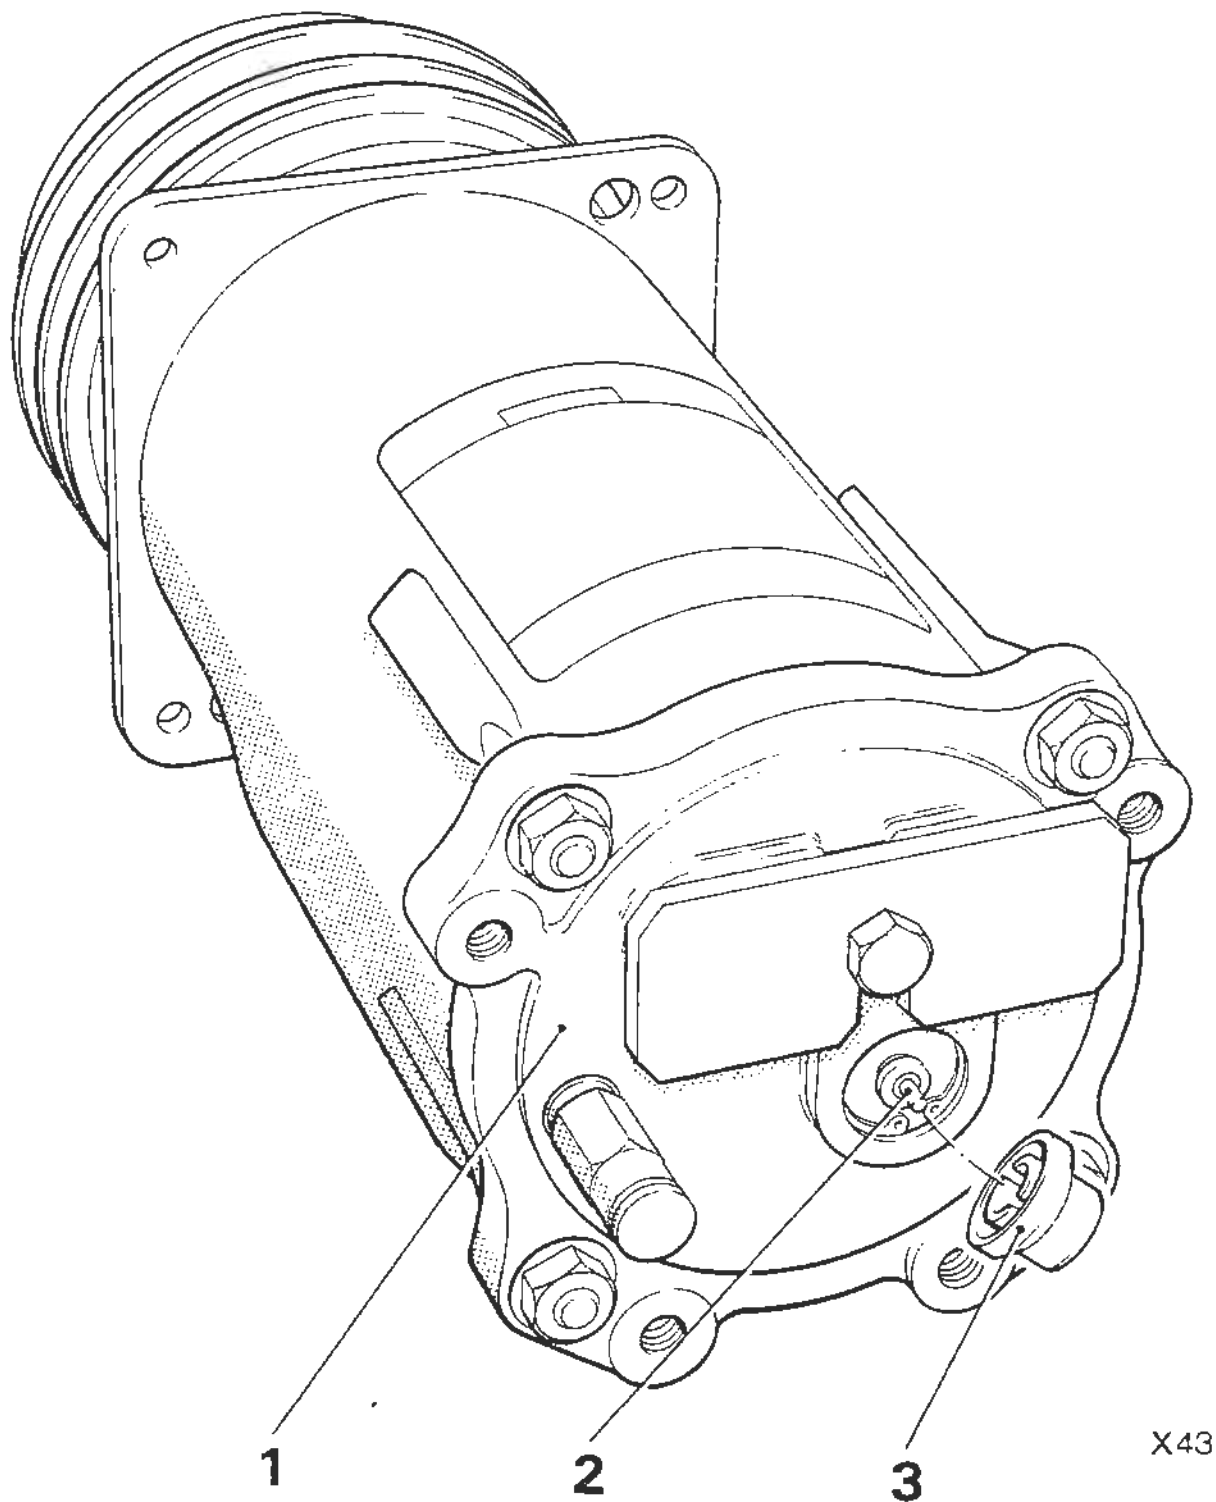
Fig. 1

When first fitting a metric air conditioning compressor to one of the above motor cars, the protection cover must be removed from the superheat switch which is located on the rear head of the compressor (see figure 1). This cover must be removed to prevent the discharge pipe from fouling surrounding components.

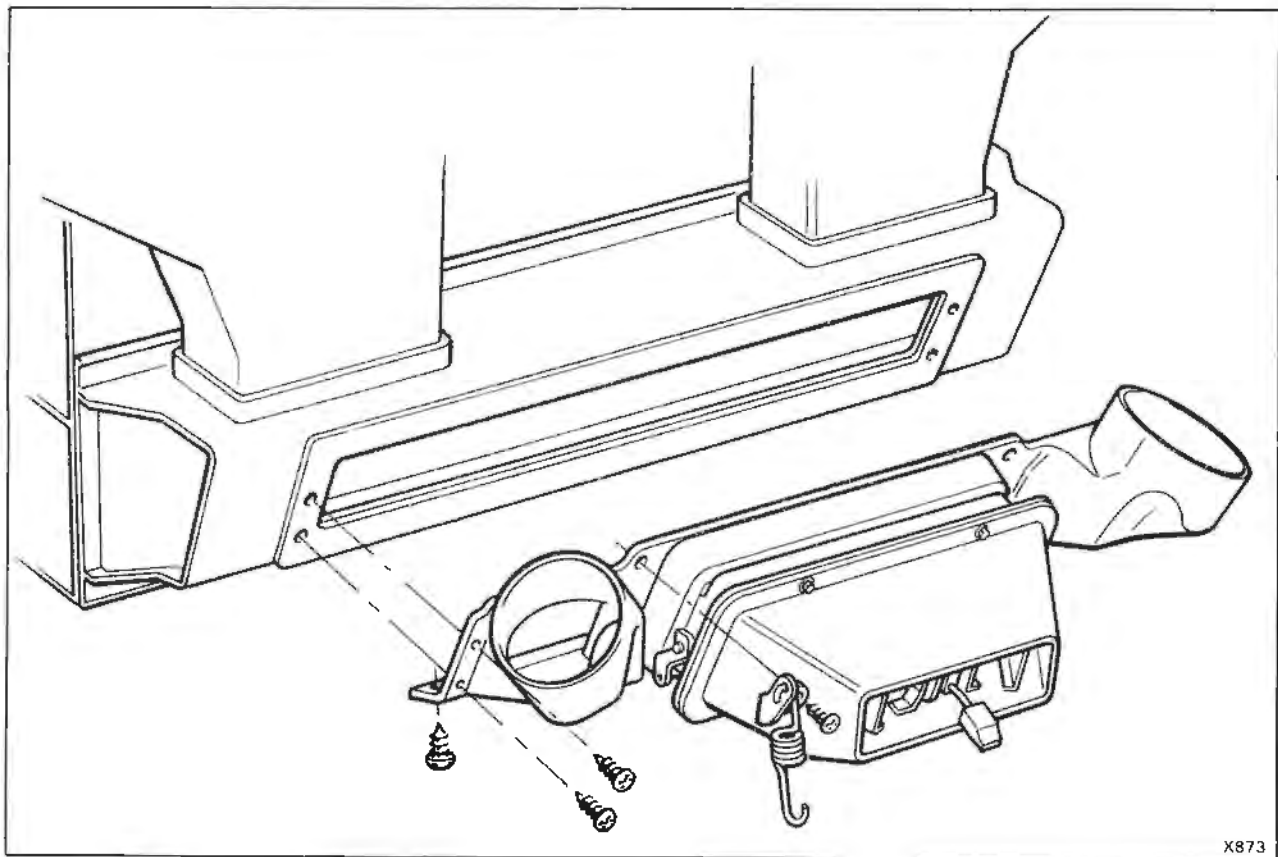
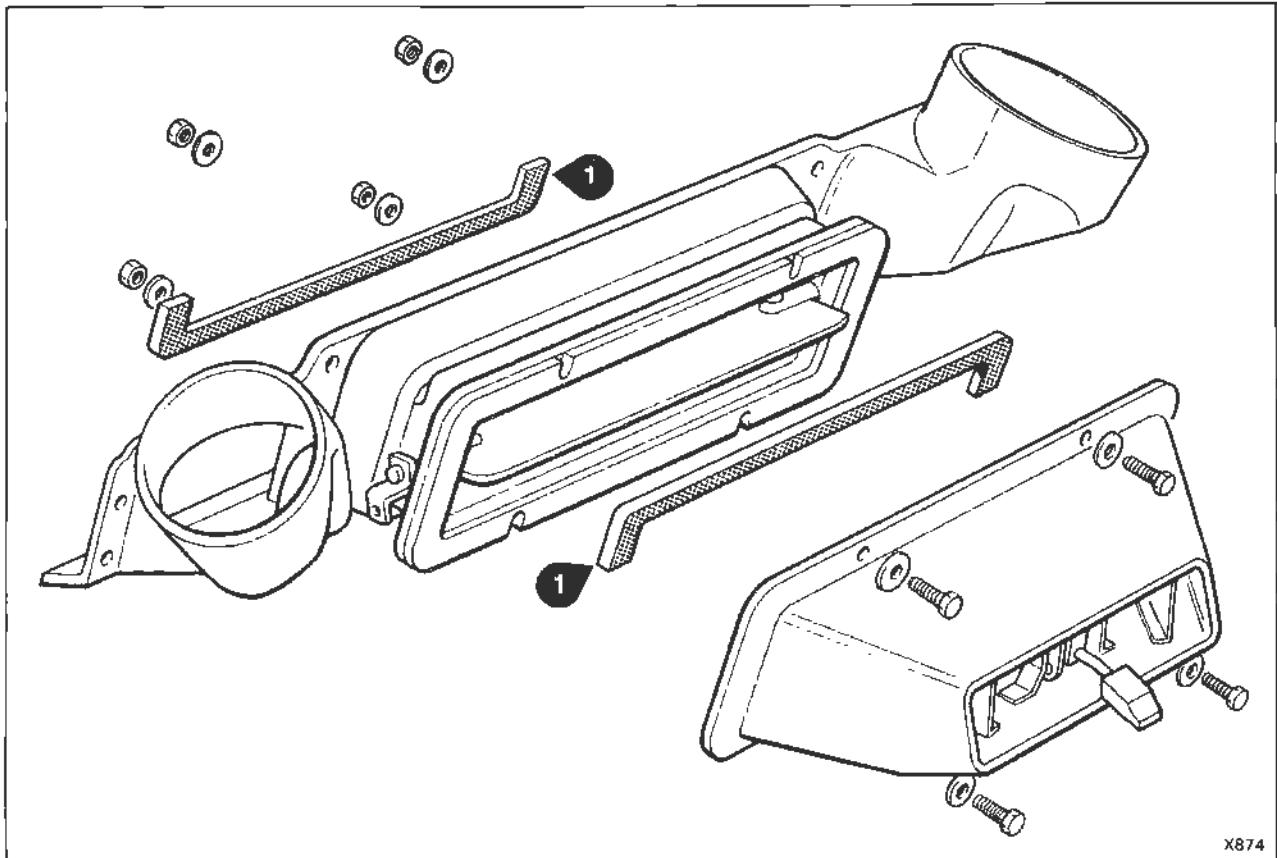
The new seals are a direct replacement for the earlier type and can be fitted retrospectively in cases where the control flaps are found to be sticking.

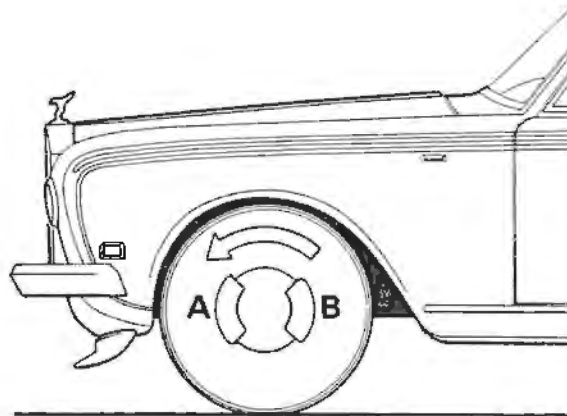
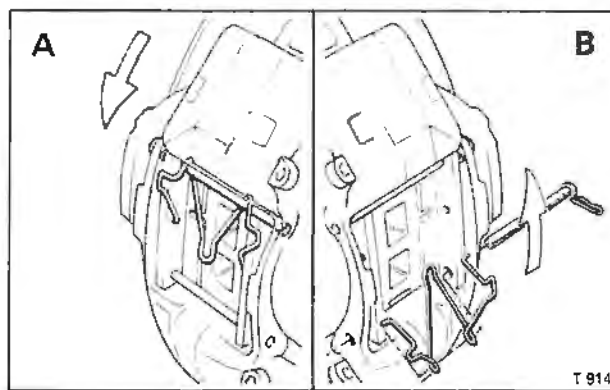
The 'M' spring must be renewed when new brake pads are fitted. This is due to the spring taking on a closer set towards the end of brake pad life, also the possible effects of corrosion.

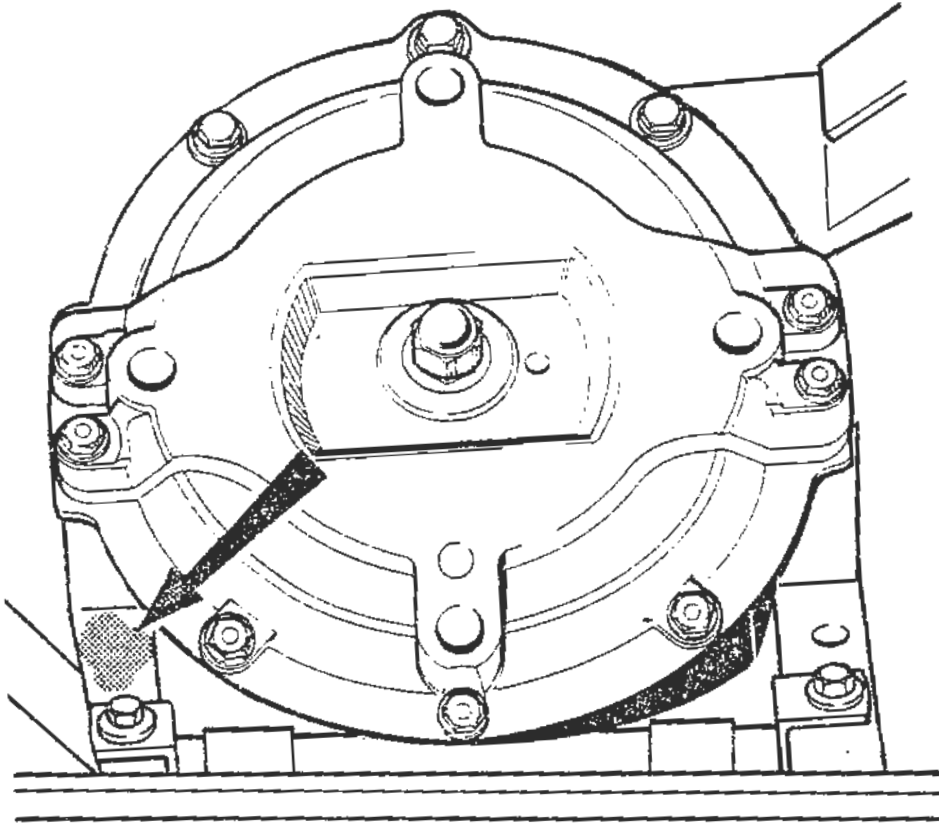
FIG 6.

Identification of cars having modification completed.
White paint spot on forward bracket adjacent to left-hand
spring pot.

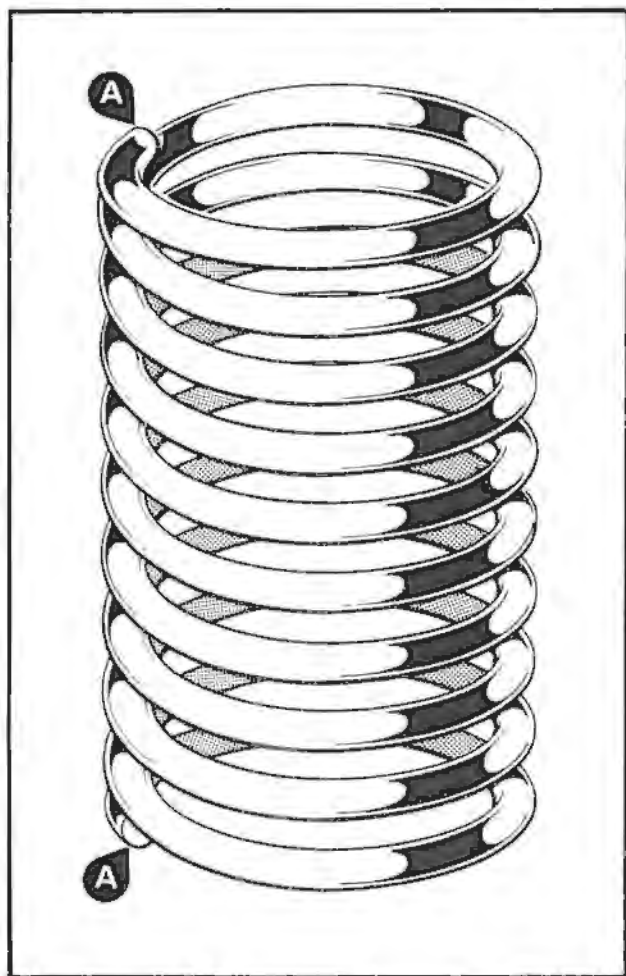
Fig. 2 New Spring

A Square cut coil ends

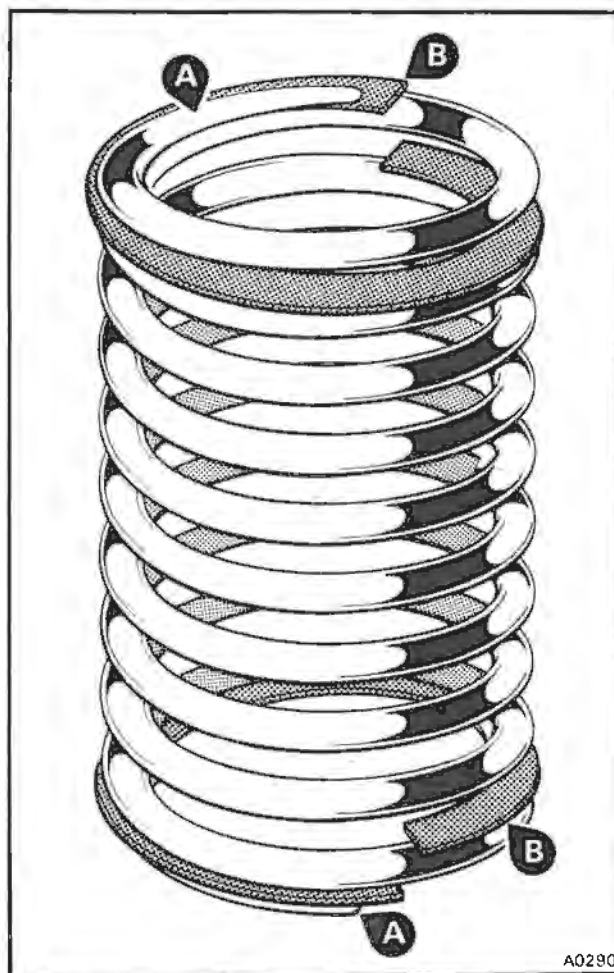
Fig. 3 Early Spring

A Chamfered coil ends
B Flexible washerPARTS AFFECTED:

- 4 Place the flexible washers between the first and second coils at each end of the springs (see fig. 3).
- 5 Compress the spring, and refit them to the car.
