## **Service Bulletins**

**Rolls-Royce Silver Cloud II**  
**Rolls-Royce Silver Cloud III**  
**Bentley S2**  
**Bentley S3**  
**Phantom V**

SERVICE INFORMATION FOR THE ROLLS-ROYCE SILVER CLOUD III  
AND BENTLEY S. 3.

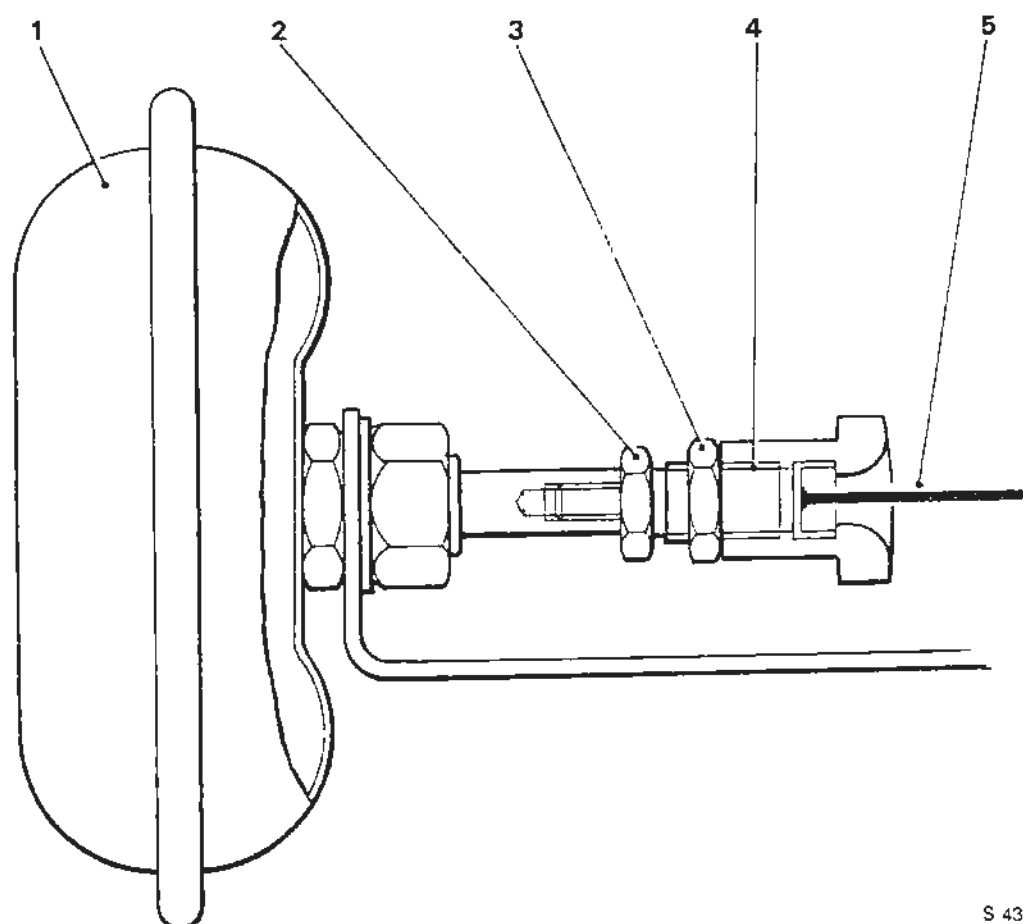
Figure 1 - Vacuum valve assembly

The existing vacuum valve unit is no longer available. Future replacements are a different type which require additional parts.

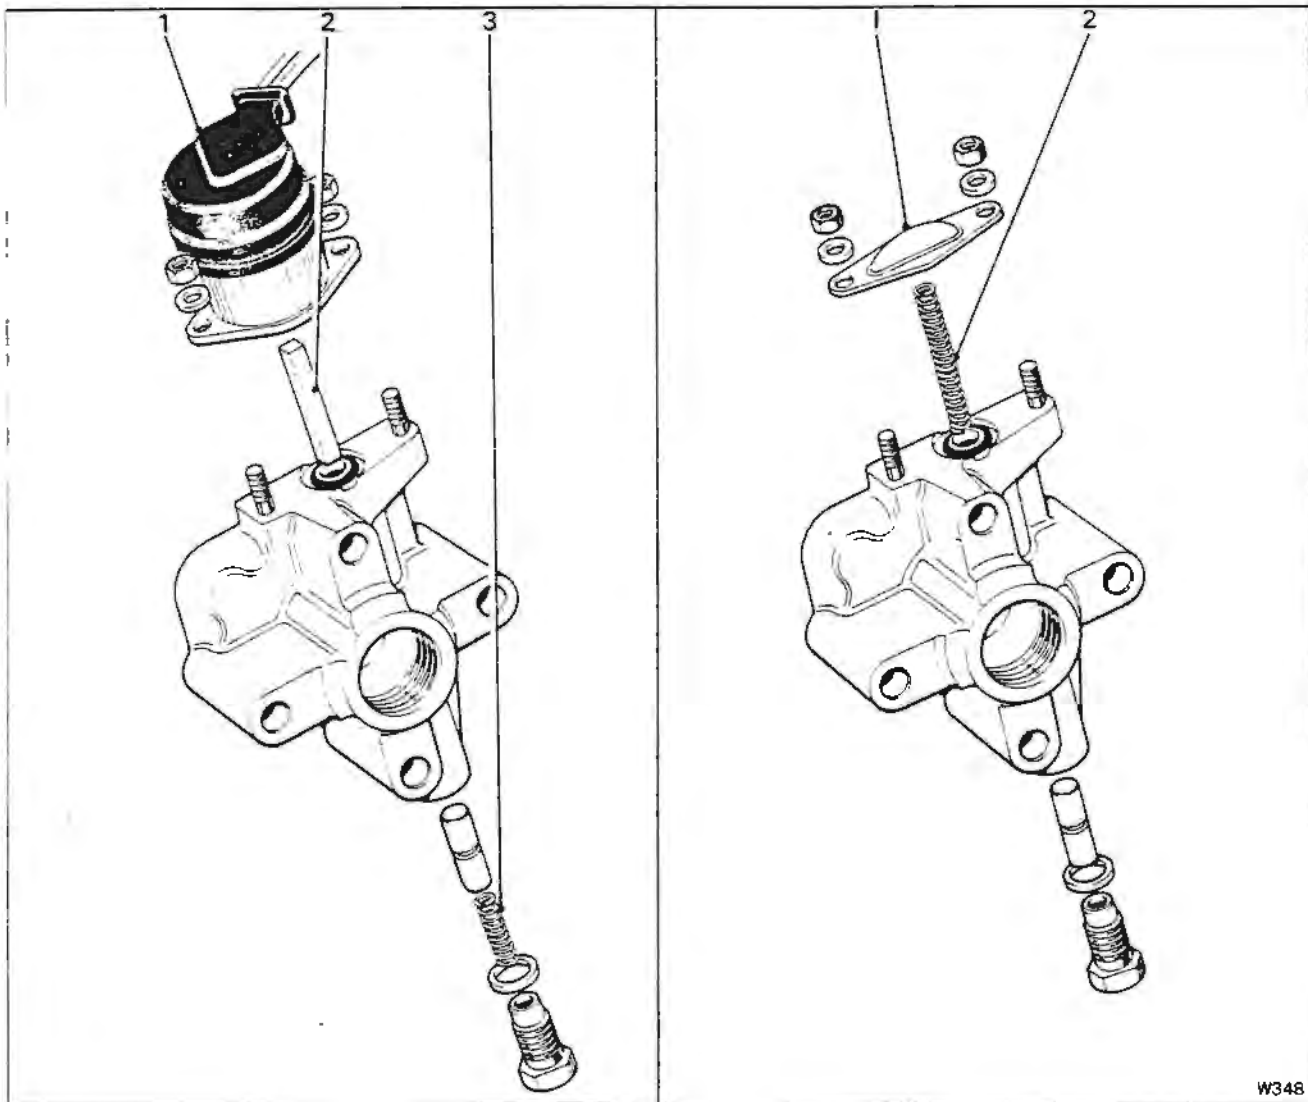
FIG 1 EARLIER ASSEMBLY

The rear damper solenoid, slow leak push rod and spring, have been discontinued. A new spring is fitted in place of the push rod and a blanking plate is fitted in place of the solenoid.

In the event of a ride control solenoid or rear damper requiring replacement on cars fitted with the two-way system, it will be necessary to modify the remaining damper and associated ride control wiring. The same procedure should also be followed in the event of a ride control malfunction.

- 3     Disconnect both the wires to each rear damper solenoid and tape them back into the loom.
- 4     Remove the ride control solenoid (see Fig.1)
- 5     Remove the solenoid spring (see Fig.1)
- 6     Remove the slow leak push rod (see Fig.1)
- 7     Fit the new spring in place of the slow leak push rod (see Fig.2)
- 8     Fit the blanking plate in place of the solenoid (see Fig.2)

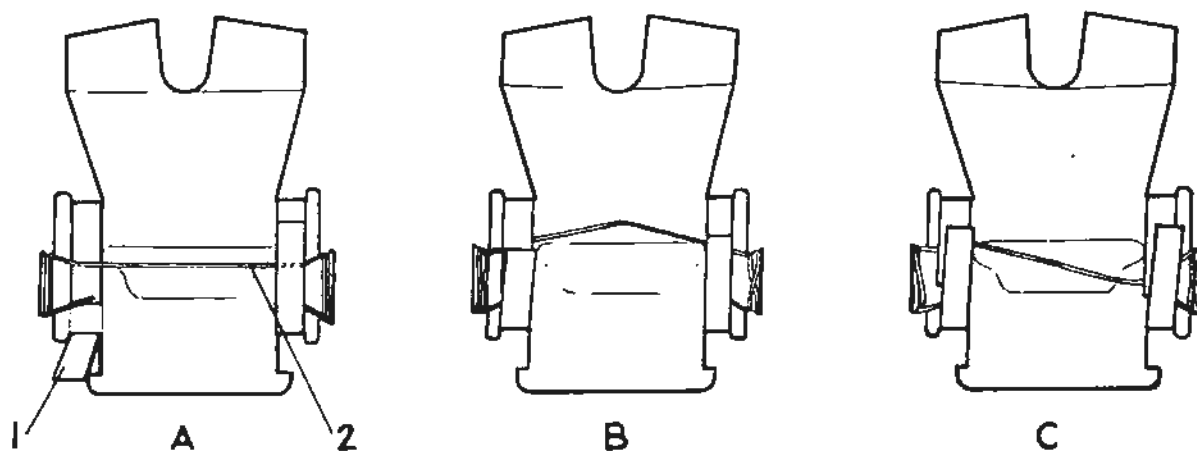
Fig.2. 'A' Correct Method of Fitting the Fuse Wire,  
'B' and 'C' Incorrect Method

The correct method of fitting the wire is shown, in comparison with incorrect methods, in Figure 2.

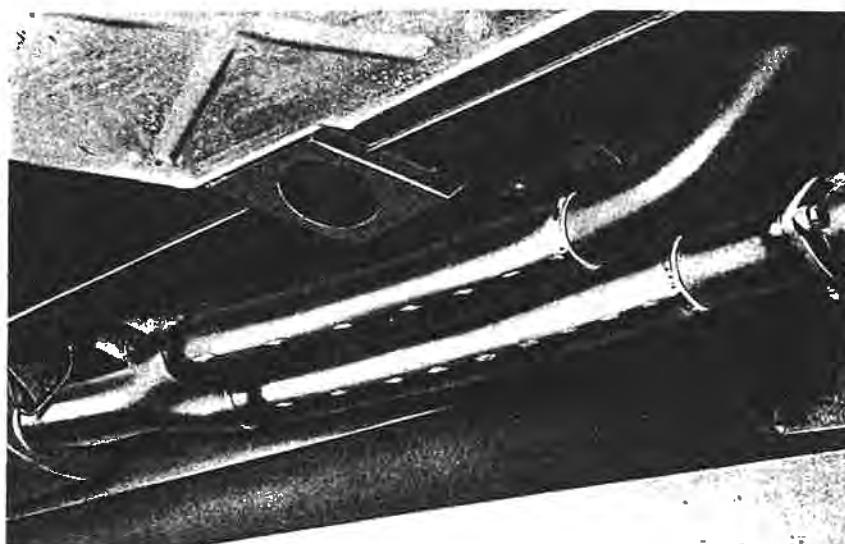
Fig.1. Position of Exhaust Pipe Lagging

A modification which provides an effective reduction in 'titter', has recently been introduced on production; this modification consists of lagging the two adjacent lengths of exhaust pipes for a distance of approximately twenty inches at a point immediately forward of the breeches piece. (see Fig. 1.)

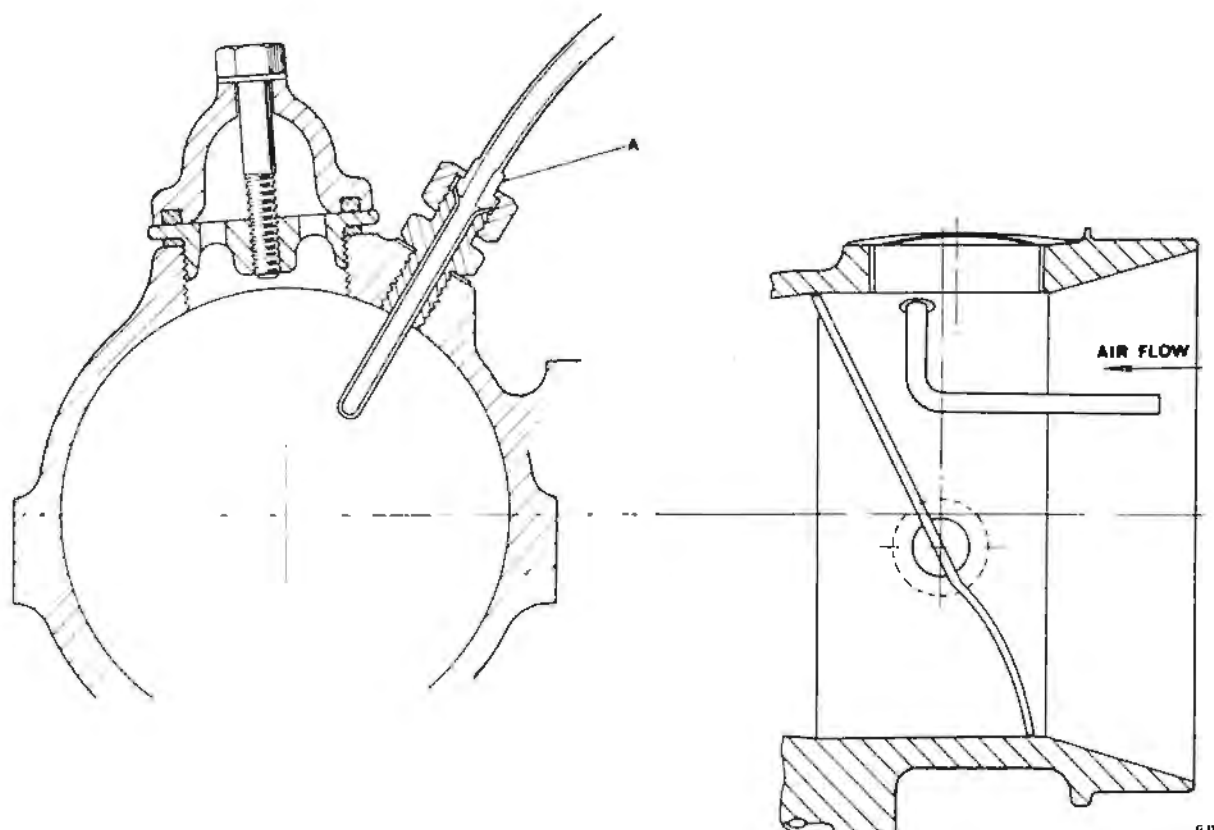
Fig.1 Diagram showing the stove pipe intake fitted forward of the oil breather outlet. 'A' shows the stove pipe nipping the swaged end of the new inlet pipe.

The presence of oil in the choke stove pipes can be readily detected by removing the bi-metal coil housing and inspecting the bi-metal coil which is usually very oily in appearance.
