**Service Bulletins
January 1979 to
September 1986 inclusive**

**Rolls-Royce Silver Shadow
Long Wheelbase,
Corniche and Camargue
Bentley T Series and Corniche
Rolls-Royce Silver Shadow II
and Silver Wraith II
Bentley T2**

T.S.D. 4318

ALL ROLLS-ROYCE FRANCHISE HOLDERS
SERVICE BULLETIN INDEX FOR TSD 4318

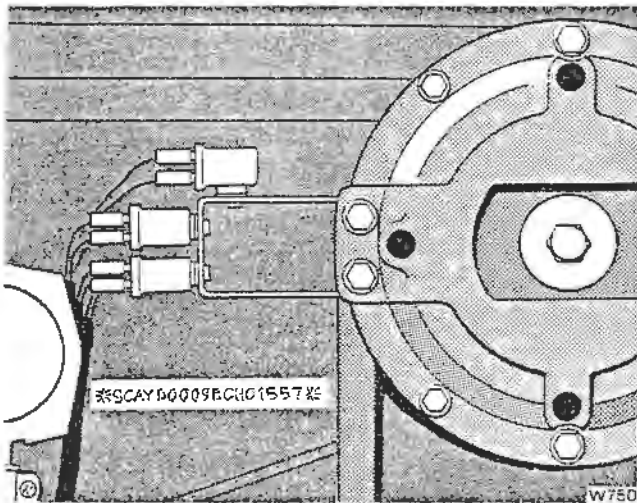
Fig. 2

Location of the vehicle identification number between the right-hand spring pot support bracket and the bulkhead.

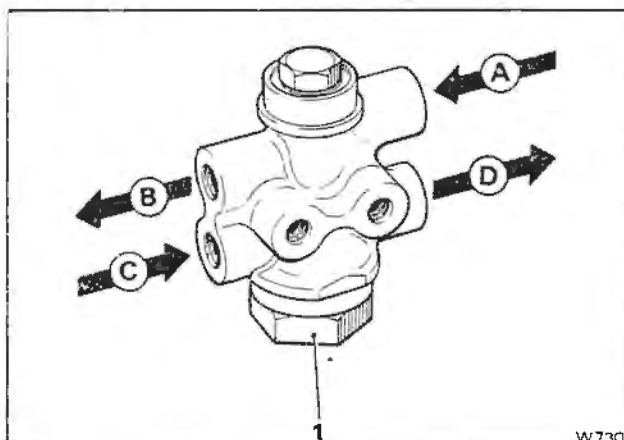
FIG. 2

1. Large end cap (letter 'R' or 'R1' etched on cap denotes later GMF 1095 minimum pressure valve for use with restrictor).

- Note
It is essential that the minimum pressure valve(s) are fitted correctly with the smaller end cap uppermost and the feed port (see Fig. 2) connected via the restrictor to the height control valve.

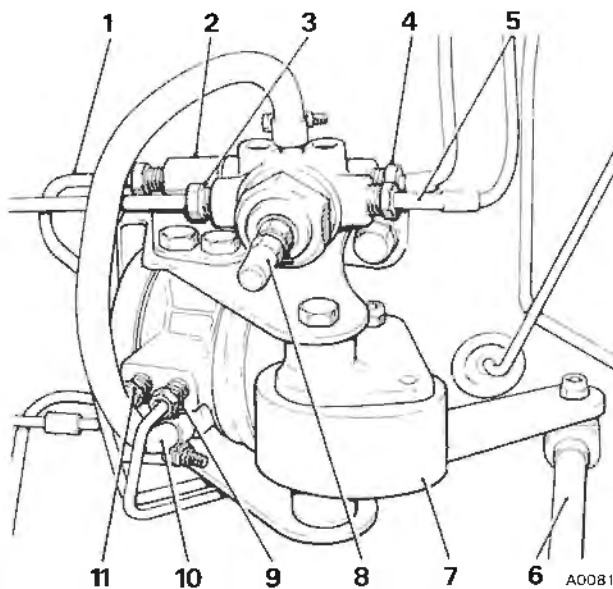
Fig. 3

- 1 High pressure feed height control valve to minimum pressure valve.
- 2 Restrictor
- 3 Low pressure return - strut drain to reservoir
- 4 High pressure feed to strut
- 5 Low pressure return - strut drain to minimum pressure valve
- 6 Height control valve link
- 7 Actuator assembly - height control valve
- 8 Adjuster - minimum pressure valve setting pressure
- 9 Low pressure return - height control valve to reservoir
- 10 Hose - height control valve drain
- 11 High pressure feed - priority valve to height control valve

- 17 Re-align and fit the minimum pressure valve to strut feed pipe into the upper port of the minimum pressure valve (see fig. 3, item 4).
- 18 Re-align and fit the strut drain to minimum pressure valve return pipe into the lower port of the minimum pressure valve (see fig. 3, item 5).
- 19 Fit the strut drain to reservoir return pipe, to the lower port of the minimum pressure valve (see fig. 3, item 3).
- 20 Fit the filter to the priority valve to height control valve pipe (early cars).
- 21 Fit the filter to height control valve pipe into the upper port of the two-way connector block with the longer leg of the pipe into the two-way connector block.
- 22 Fit the height control valve to reservoir return pipe, into the lower port of the two-way connector block.
- 23 Re-clip the hydraulic pipes to the floor of the car.

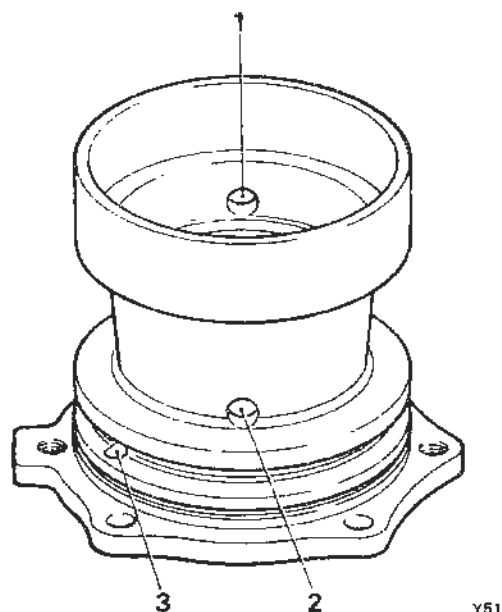
Fig. 1

- 1 Oil delivery hole - pinion centre bearing
- 2 Oil delivery hole - pinion tail bearing
- 3 Oil return hole - pinion tail bearing

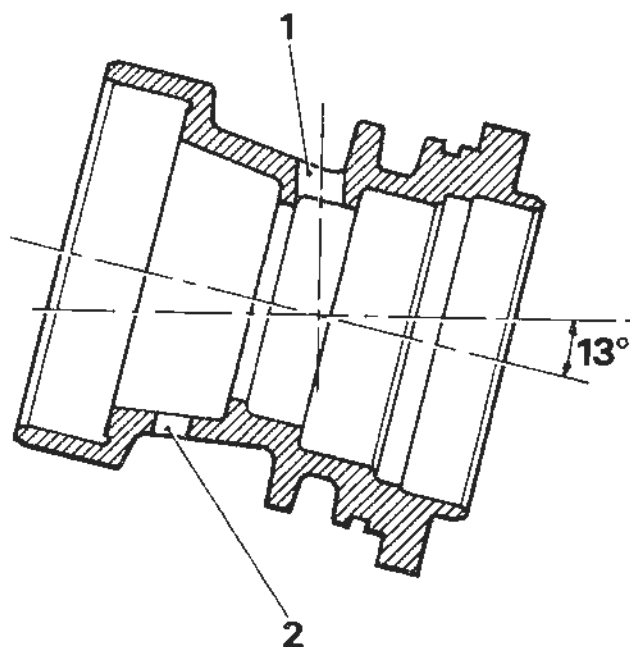
Fig. 2

- 1 Oil delivery hole - pinion tail bearing - drilled at revised angle
- 2 Oil delivery hole - pinion centre bearing

- 1 Remove the pinion from the housing.
- 2 Place the pinion housing in a suitable vice with the oil delivery hole vertically uppermost (see fig. 3).
- 3 Tilt the pinion housing to an angle of 13 degrees from the horizontal plane, (see fig. 2) and secure it in the vice.

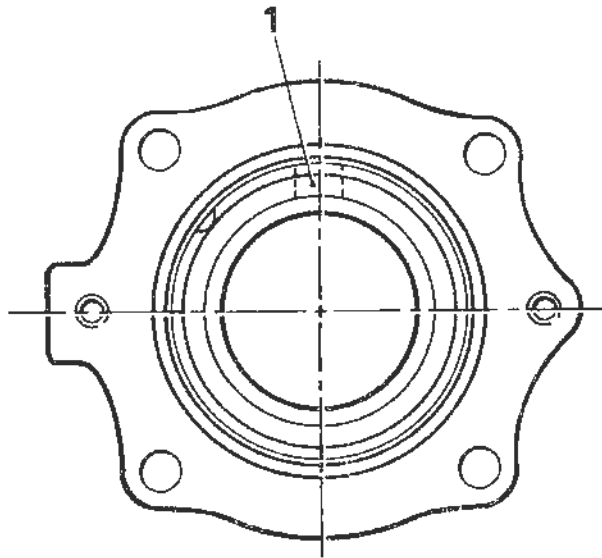
Fig. 3

- 1 Position of oil delivery hole when secured for drilling

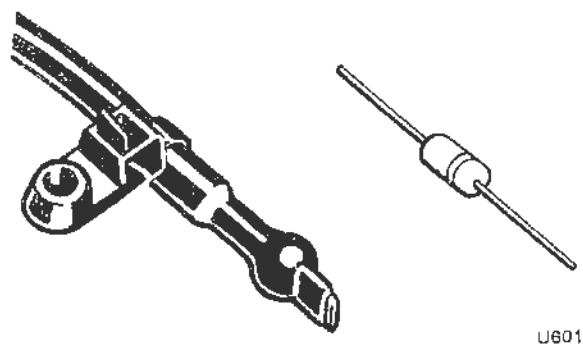
Replacement sensors will be supplied with a resistance value of 7000Ω . In effect this resistance is the same value as the sensor at 10°C ambient temperature. The resistor is used to calibrate the amplifier (see Fig. 1).

Fig. 1 Replacement sensor and resistor

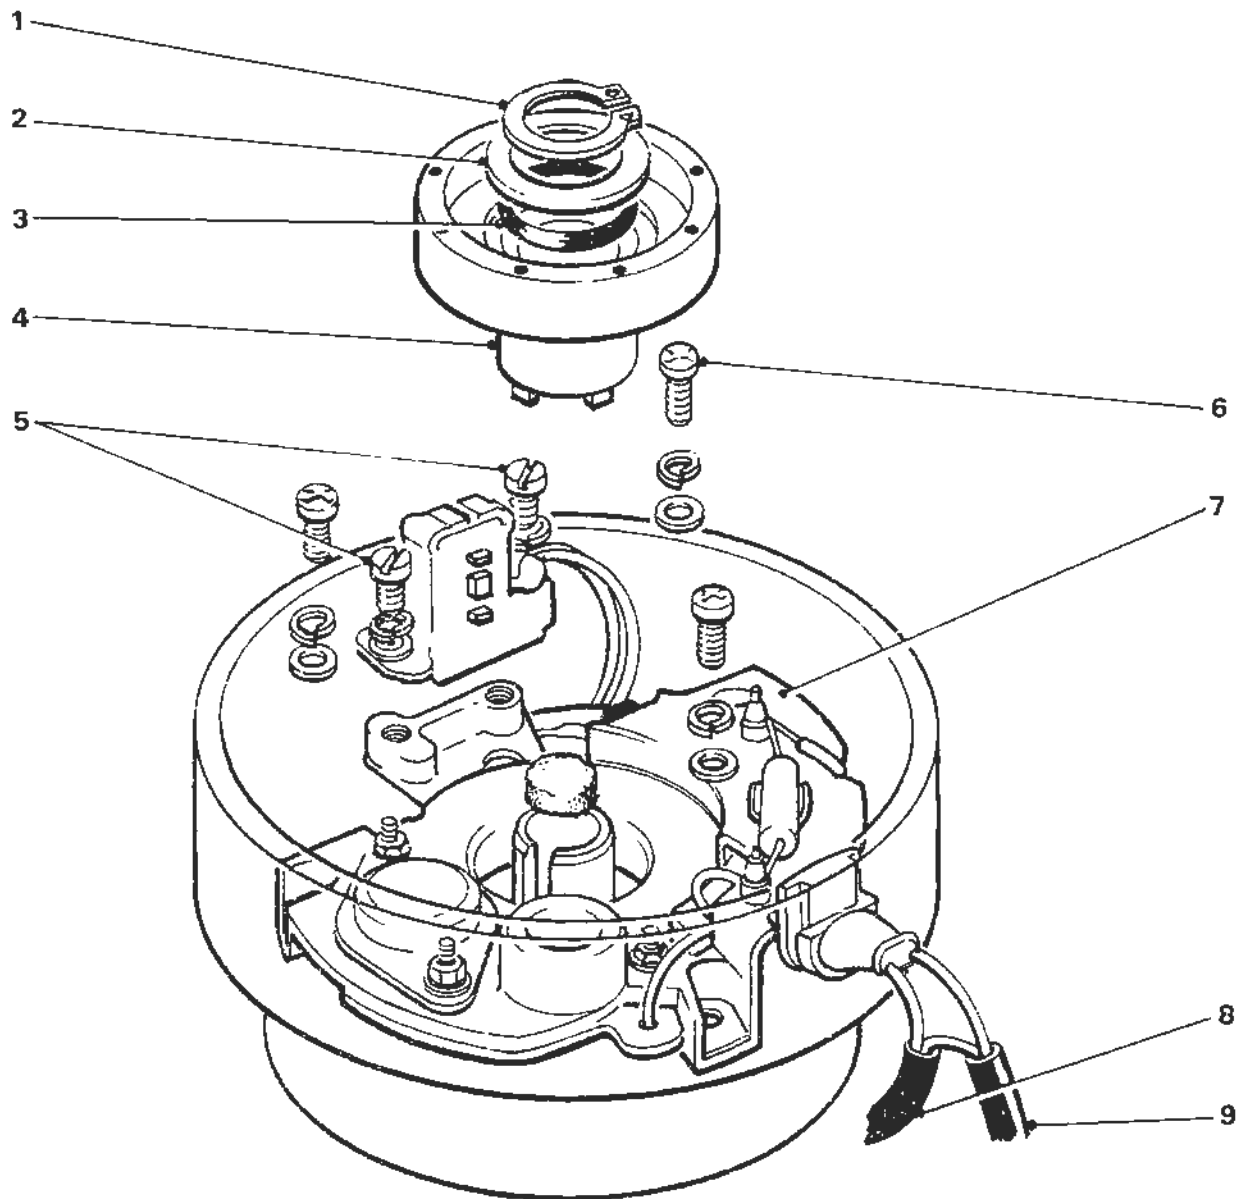
T 678

FIG 1
EXPLODED VIEW - ELECTRONIC MODULE AND TIMING ROTOR ASSEMBLY

In the event of a distributor module failure it will be necessary to replace the module by one of a later type. A conversion kit RH2752 will be required. This bulletin has been issued to describe the fitting procedure.

NOTE: The air gap limits are 0,30mm. - 0,43mm. (0.012in. - 0.017 in.) The feeler gauge should be a sliding fit. Do not use oversize feeler gauges to check the gap as the 'E' core sensing heads can easily be damaged. Do not attempt to measure the air gap with the distributor on the car and the ignition switched on.

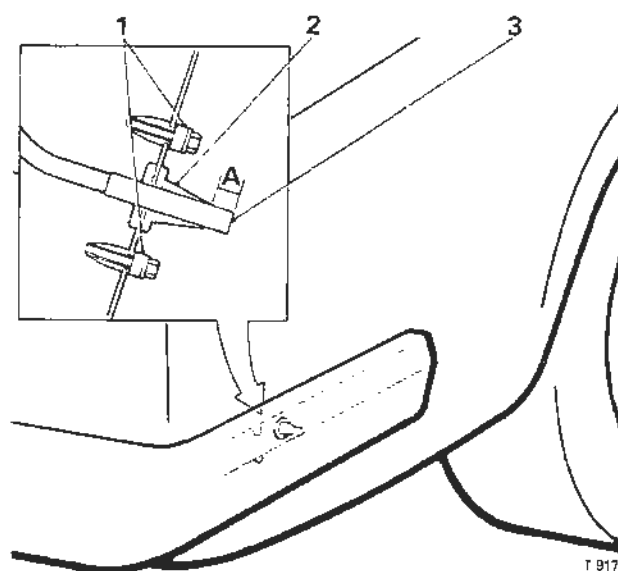
T 917

In the event of a failure, it will be necessary to replace the sensor by one of a later type.

Fig. 1 showing new type sensor fitted to the body.

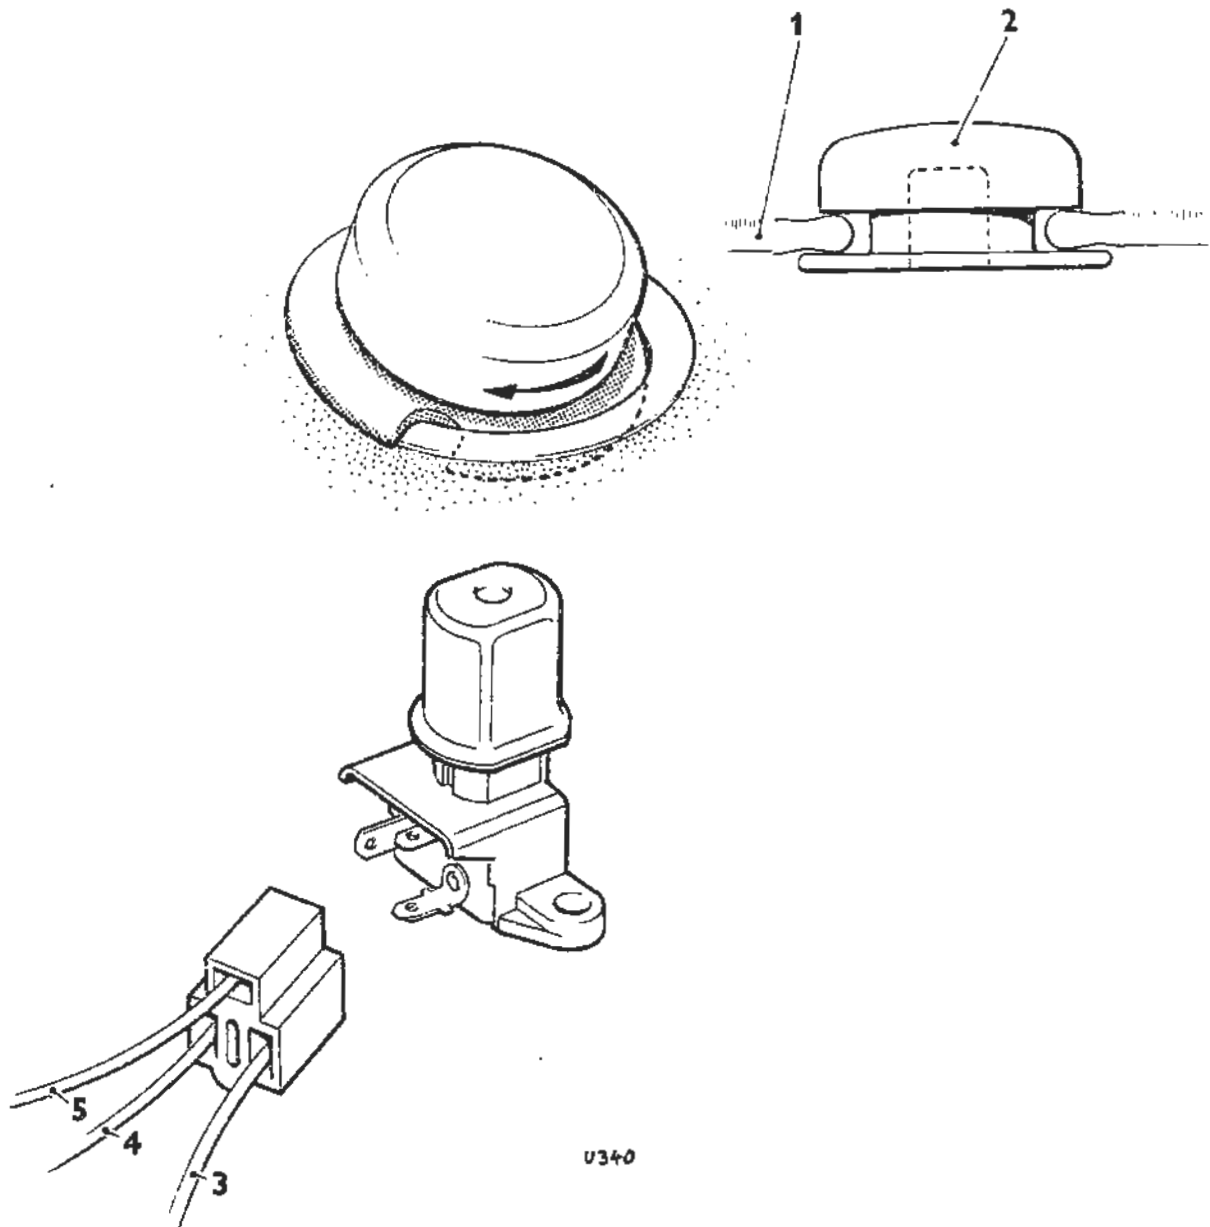
U340

FIG 1 - SHOWING THE POSITIONS OF THE CABLES IN THE 3 WAY PLUG AND ALSO THE CORRECT FITTINGS OF THE PROJECTOR SHOE TO THE CARPET.

1. Disconnect and remove the failed dipswitch.
2. Remove the existing 'bullet' type connectors from the dipswitch wires and fit the 'Lucar' type connectors from the RH 2775 kit.
3. Connect the dipswitch wires into the 3 way plug supplied in the RH 2775 kit as shown in Figure 1.
4. Using the insulating disc from the old switch and the new screws from the RH 2775 kit fit the new type dipswitch in the same position as the original switch.

5. Connect the 3 way plug to the dipswitch.
6. Ensure that the switch operation will not be restricted by the carpet underlay or the edge of the transmission tunnel carpet. If necessary, trim the material to give adequate clearance.
7. Fit the new rubber protector shoe to the carpet as shown in Figure 1 and replace the carpet making sure that the rubber shoe is pushed firmly onto the dipswitch.

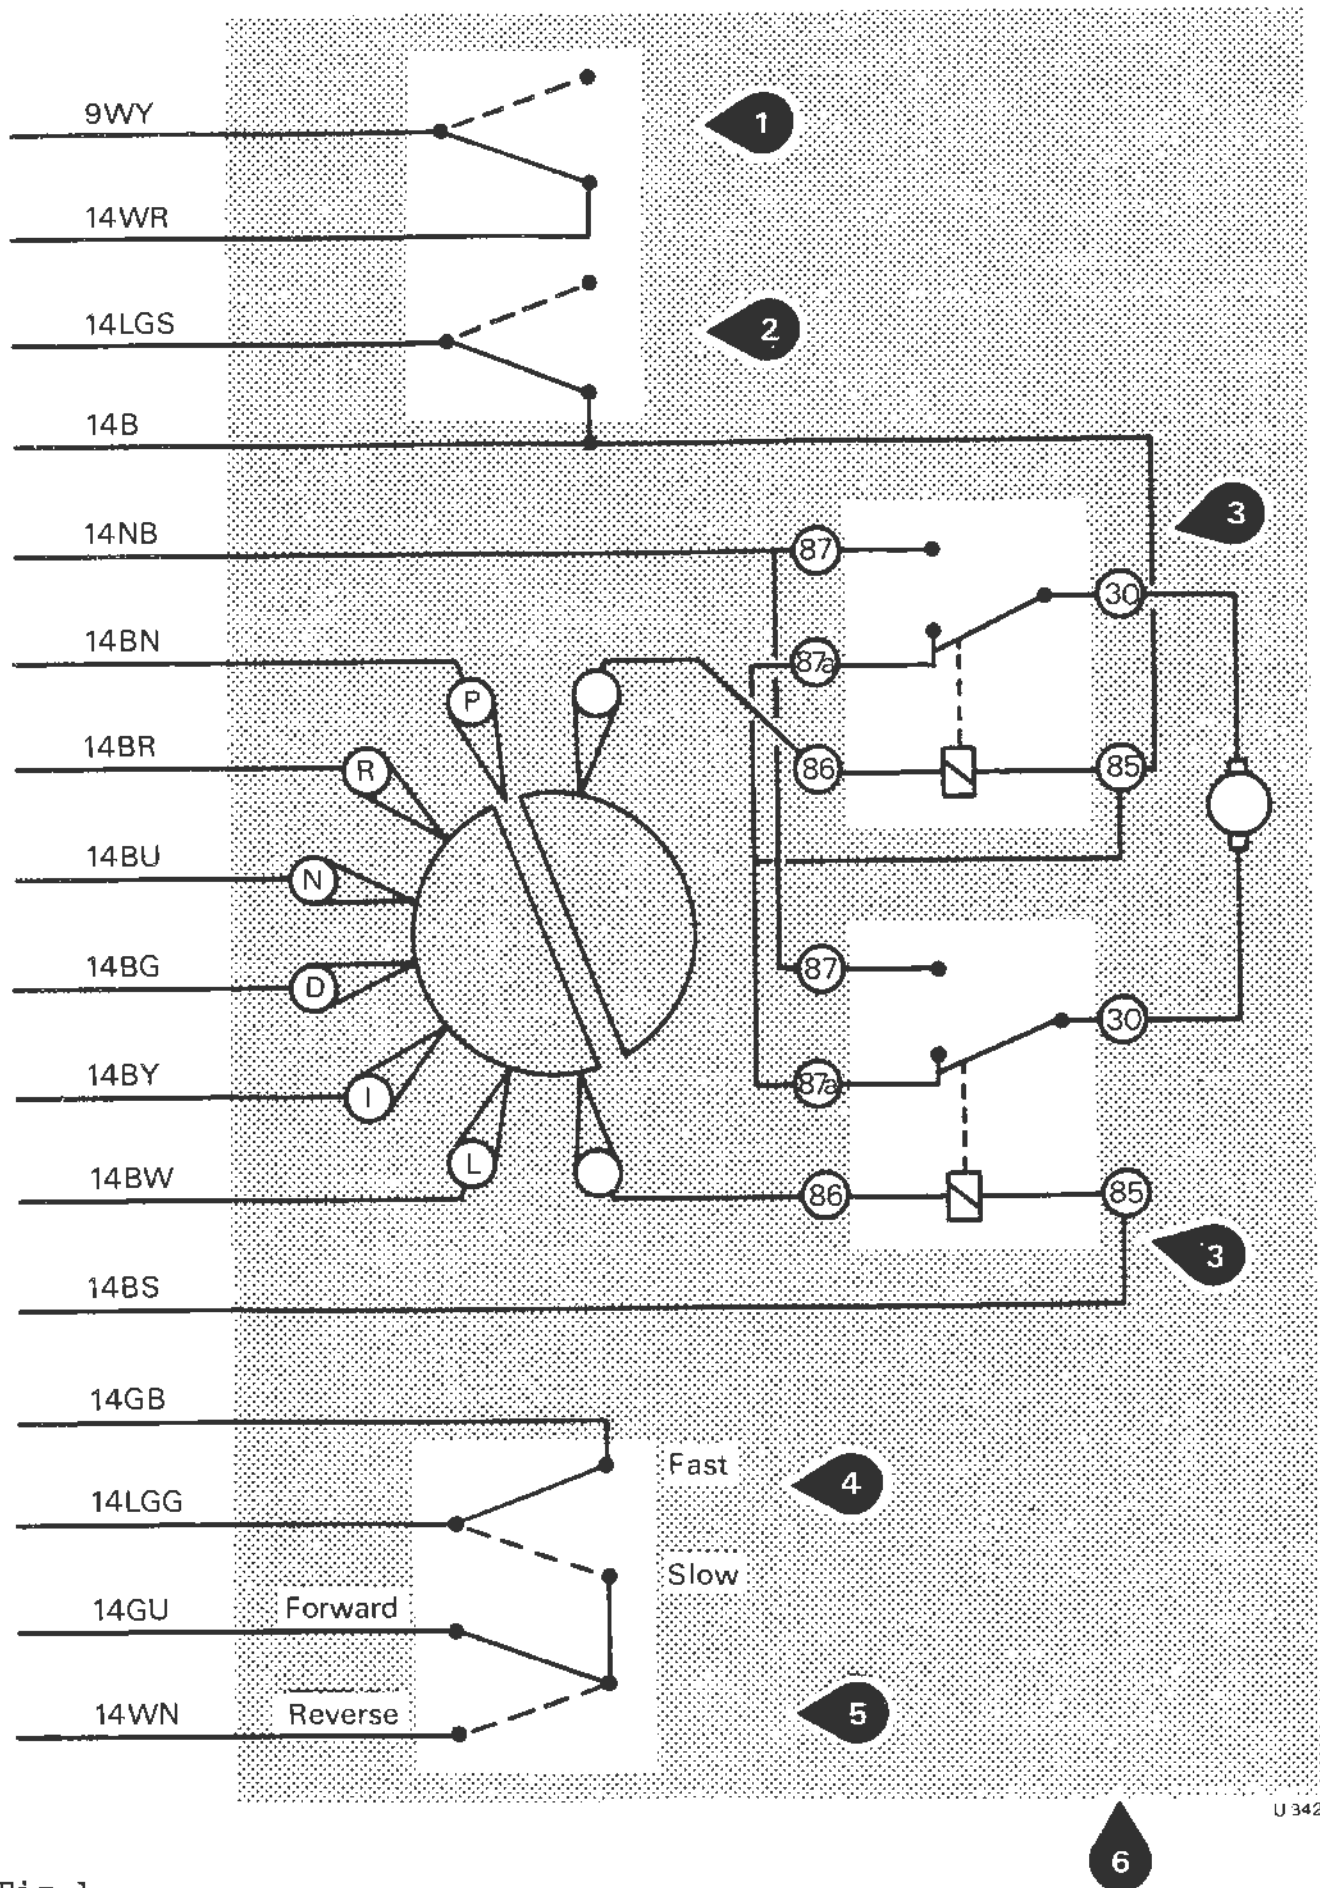
Fig 1

The Lucas Dual Relay part number UG 13111, has been replaced with a pair of Bosch 'mini-relays' part number UD 22452. This has necessitated changes to the wiring of the relays as shown in Figure 1.

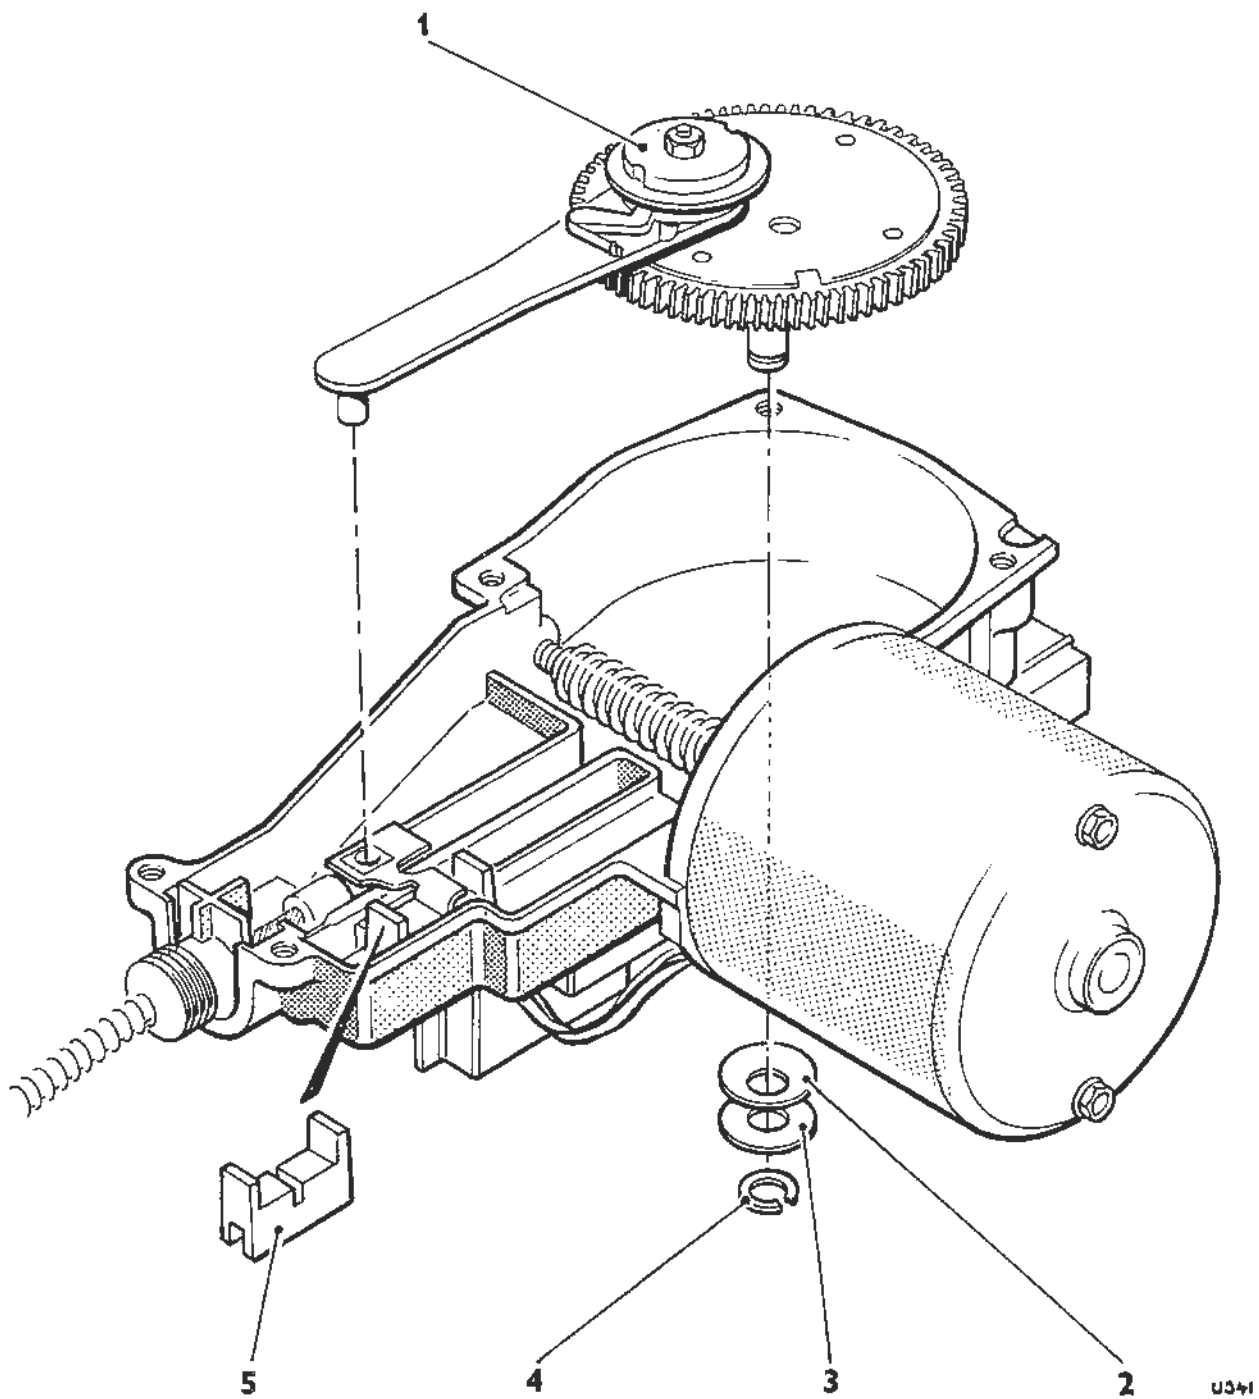
FIG. 1

The parking switch of this motor is provided with an adjustment to allow for different angles of park. When replacing a drive gear assembly it may be necessary to readjust the parking switch to suit the new assembly. Failure to do this may result in one of the following faults.

- 1 With the wiper switch in the intermittent position and the blades parked on the screen, moving the switch to the off position does not cause the blades to move to the off screen position.
- 2 When moving the wiper switch from off to intermittent there is a 7 to 8 second delay before the wiper motor operates.

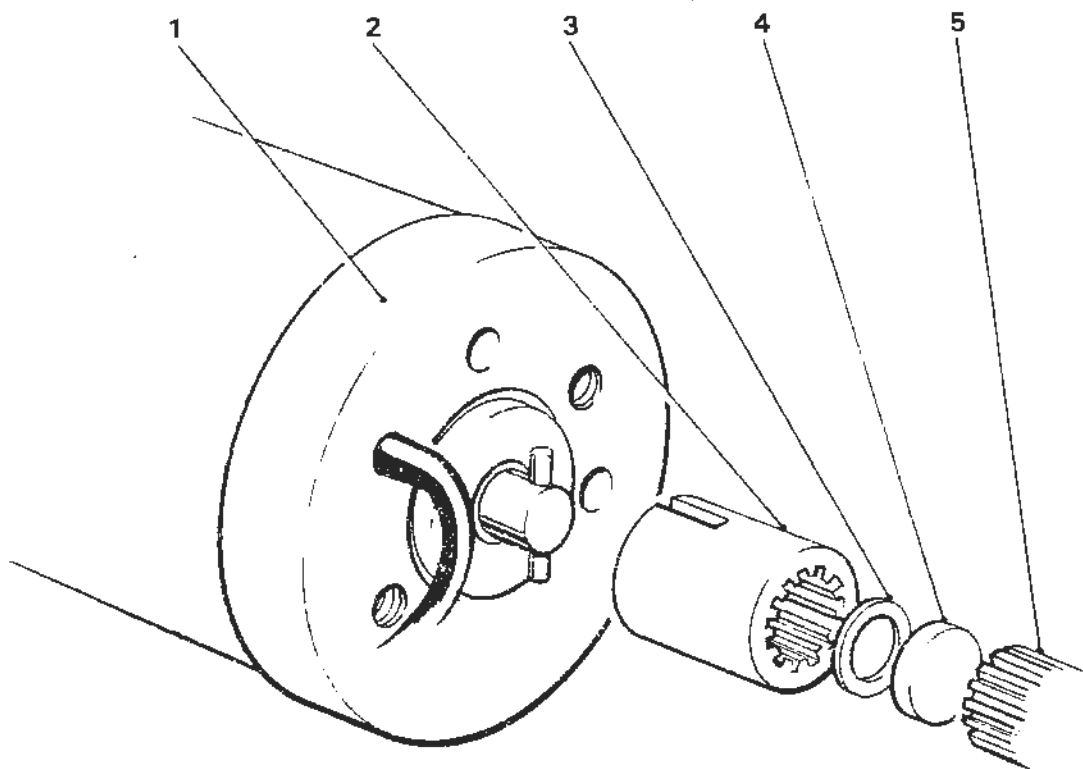
U870

Window lift drive motors as fitted to the above cars are no longer available. A new type of motor has been introduced which will directly replace the earlier motor when used with a special coupling and packing washers. The new type motor and coupling are available as a kit of parts, RH 2786 or RH 2787.

Figure 1

Showing the Motor, Coupling, Packing washer and the Window lift drive-shaft.

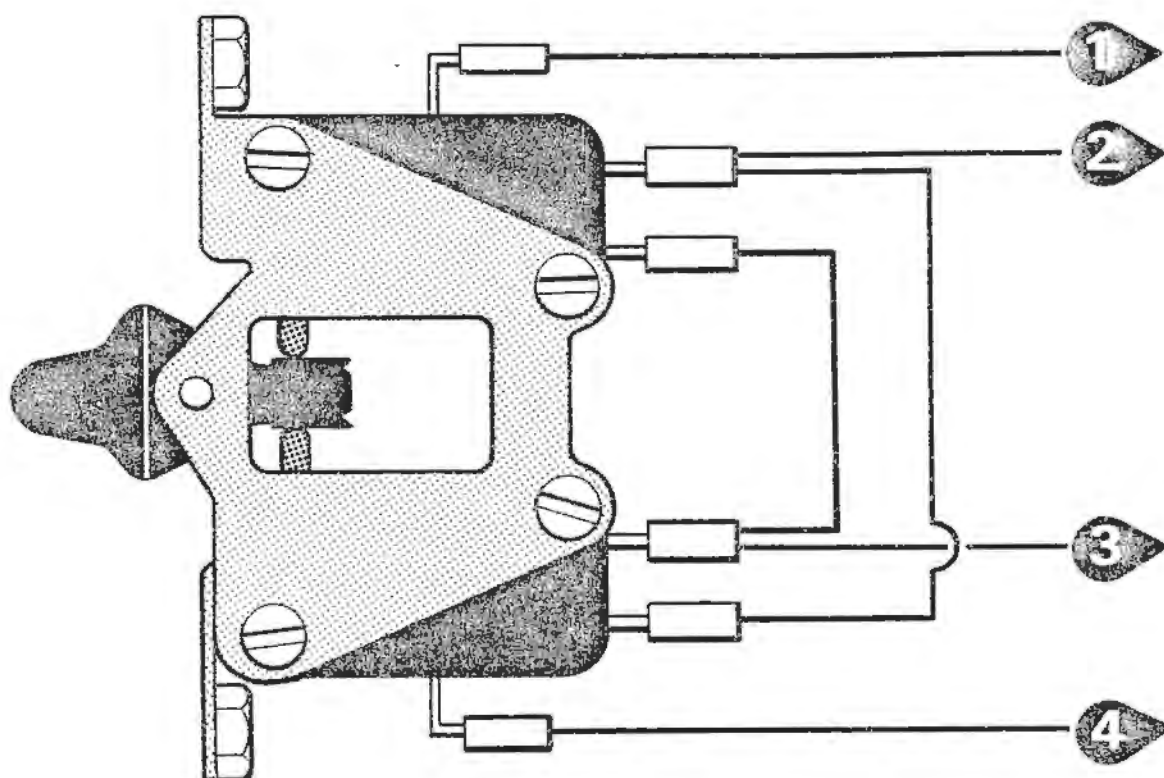
FIG 4

Radio aerial switch and wiring

1. Cable to aerial - colour will be either LGR, GB or GR
2. 12 volt supply from fuse
3. Cable to earth point - see fitting procedure 11 and 12
4. Cable to aerial - colour will be either LGU or GU

PROCEDURE FOR REPLACING A DAMAGED AERIAL MAST:

1. Ensure that the aerial is in the fully extended position.
2. Cut off the damaged mast approximately 25,0 mm (1.0 in) from the wing crown nut to enable the RH 9653 spanner to be fitted.

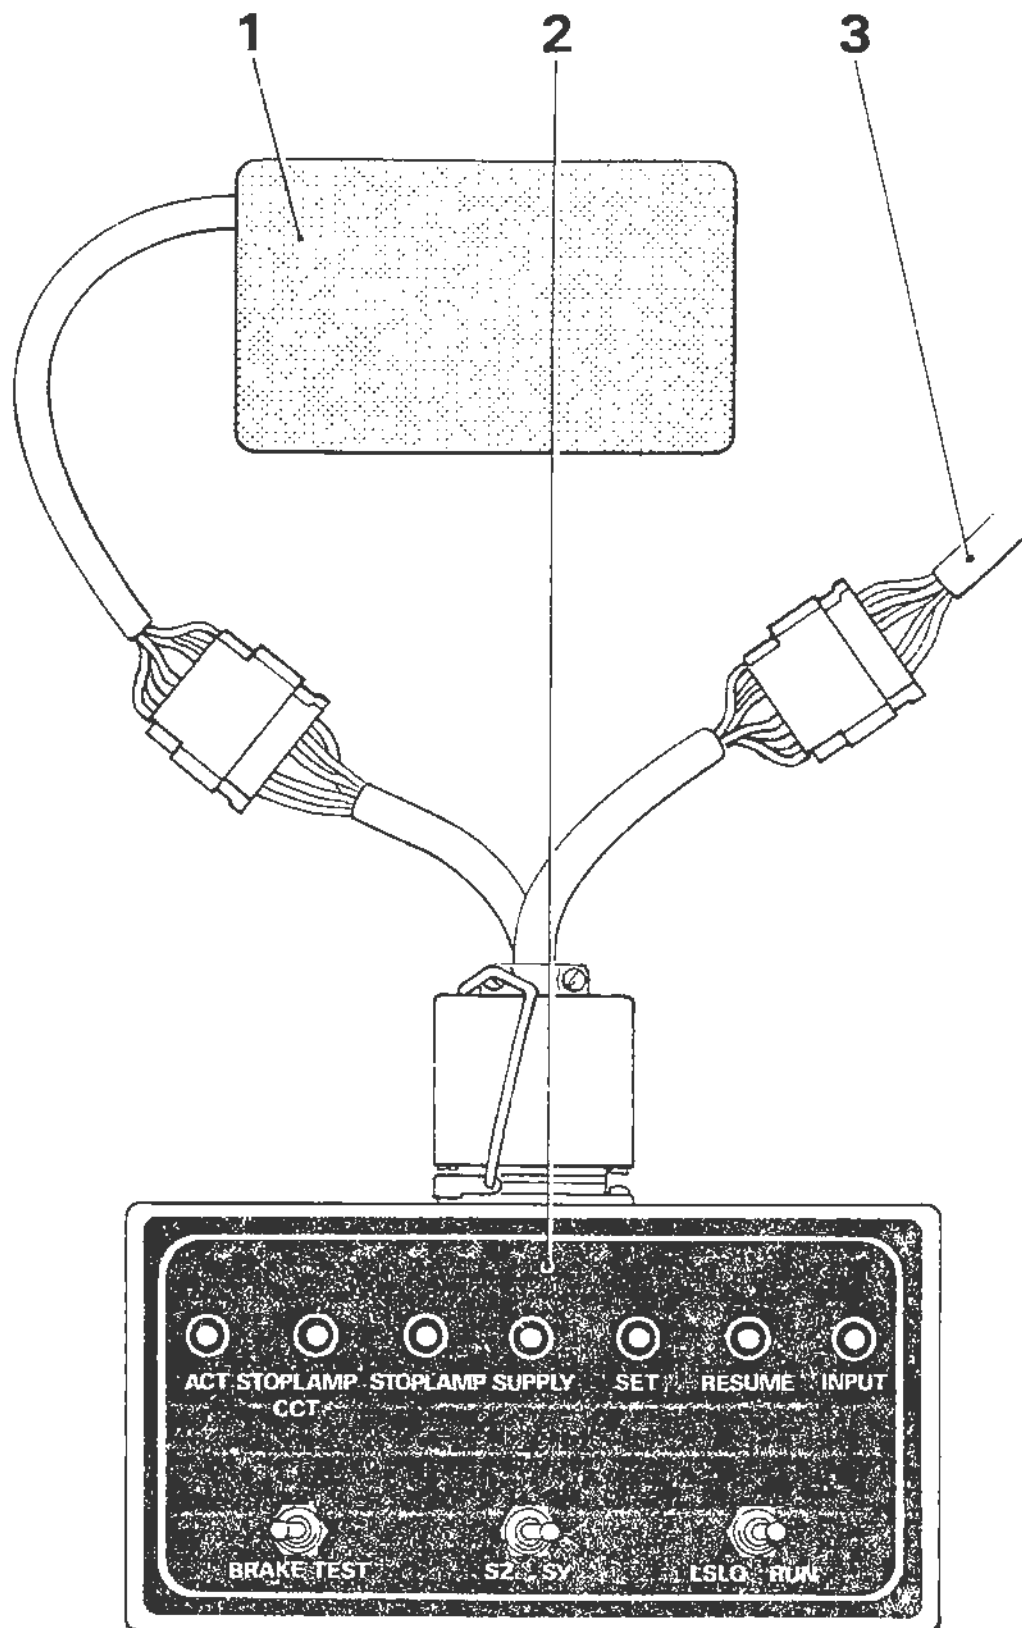
FIG.1

- 1 Electronic speed control unit
- 2 RH 9689 speed control test box
- 3 Car speed control wiring loom.

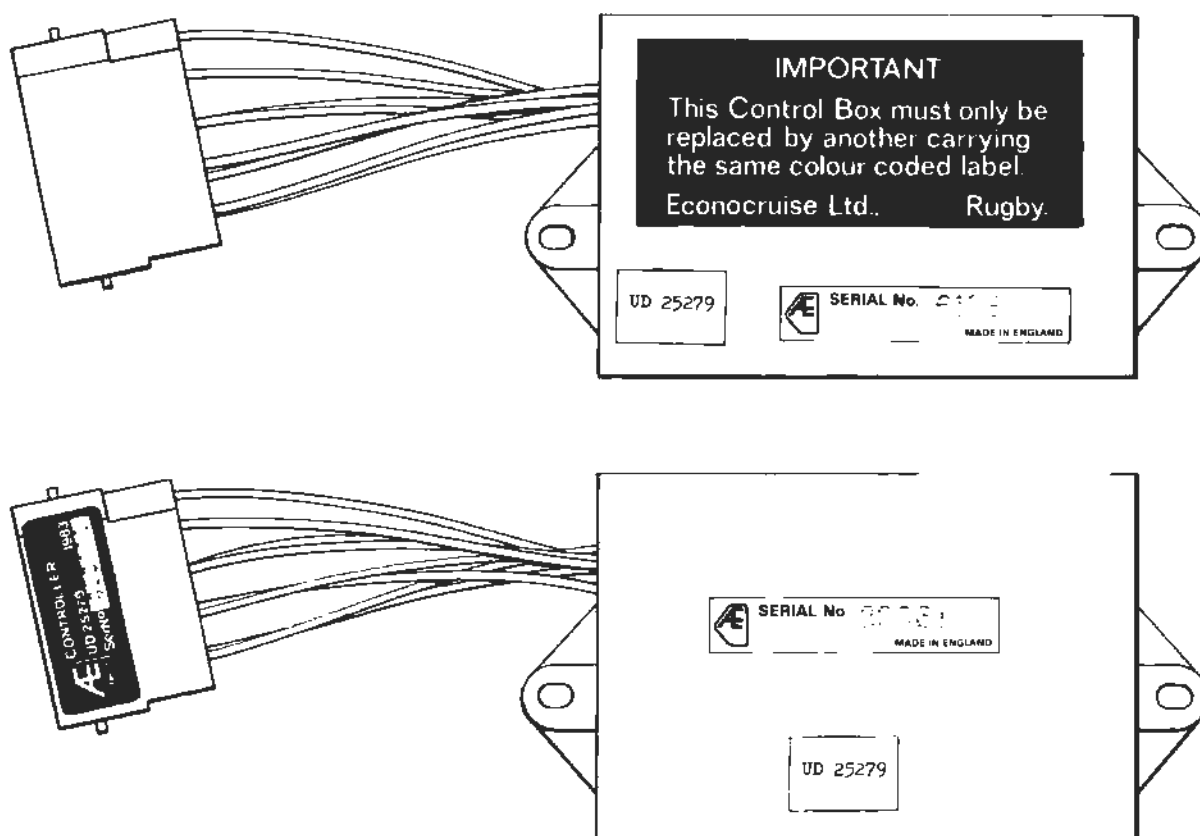
A revised speed control unit has been introduced to replace the previous type.

Fig. 1 Revised UD 25279 Control Box

The new unit can be used for all replacement purposes on the above vehicles.

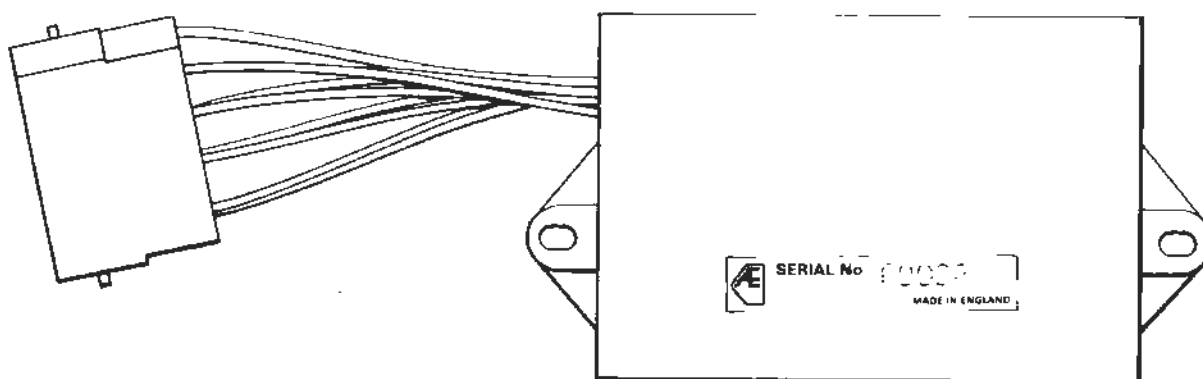
Fig. 2 Early UD 23343 Control Box

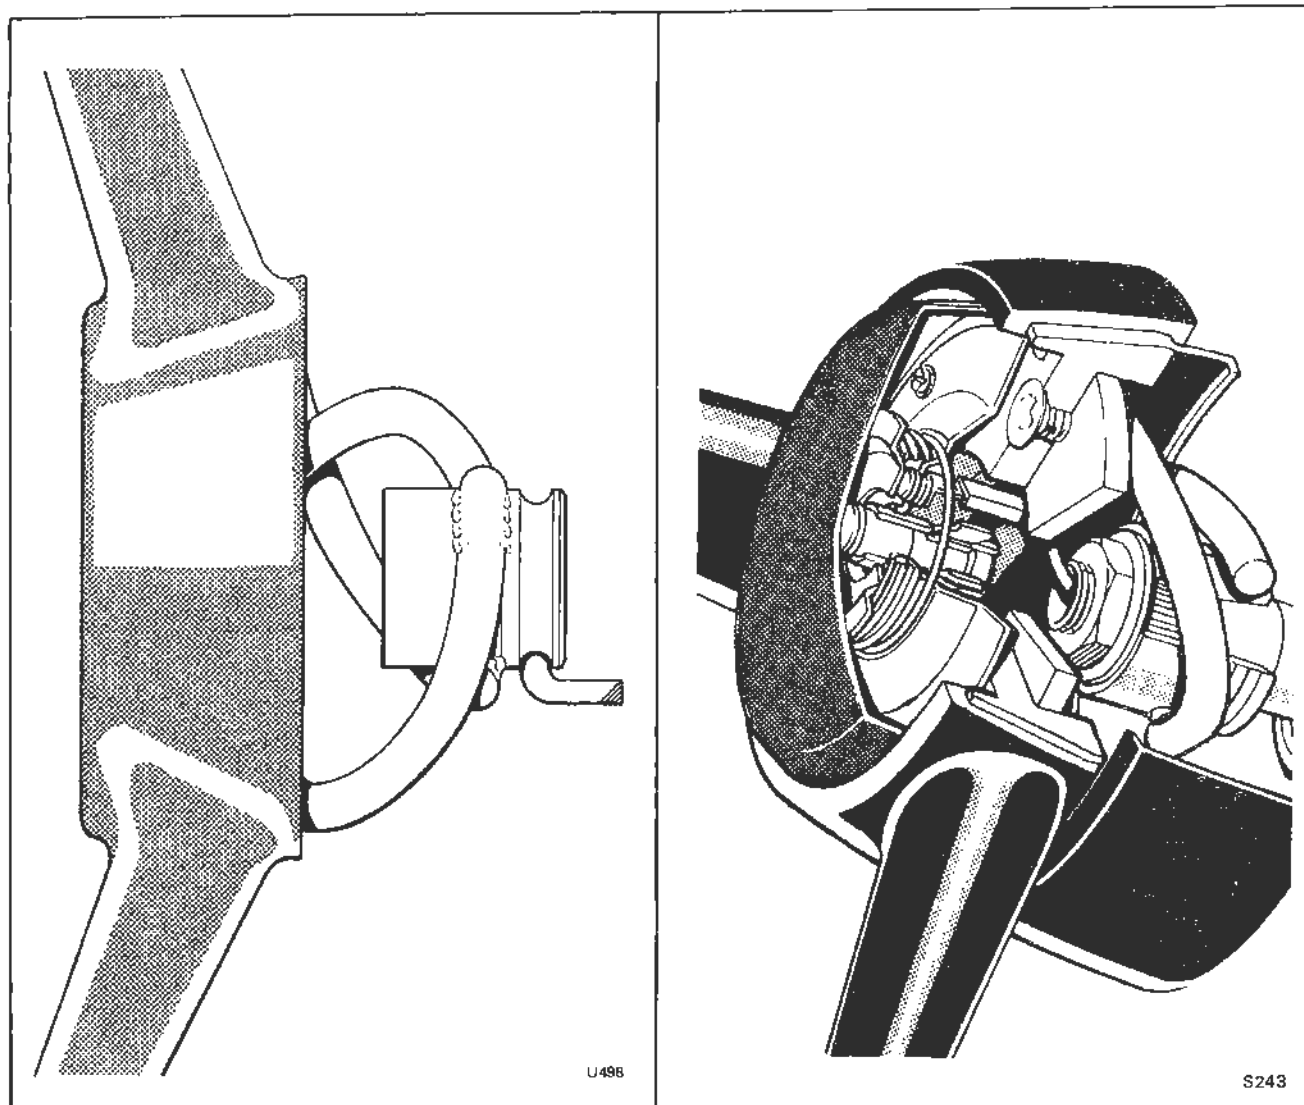
Fig. 1 Shaping the peg

1. Disconnect the battery.
2. Feed a 31 cm. (12.0 in.) length of strong thin string in a loop into the gap between the push button and the steering wheel surround.
3. Grip the two free ends of the string and with a sharp pull release the push button and withdraw the assembly. Retain the coil spring.
4. Unscrew and remove the support plate taking care to disconnect the cable attached to the underside of the plate.
5. Remove the steering wheel centre nut and washer using a 7/8 in. A/F, deep body, hexagon socket spanner.
6. To fit the new wheel reverse the removal procedure ensuring that the indicator cancel peg on the new wheel has been shaped so as not to cause a foul situation with the gear change lever when in the LOW position.

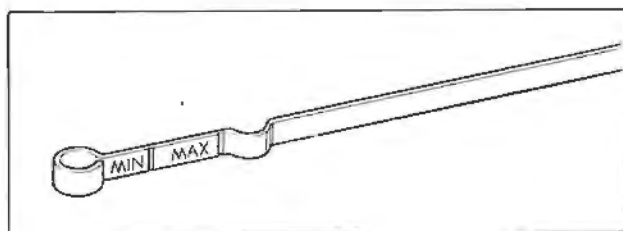
Fig. 1
Early type dipstick

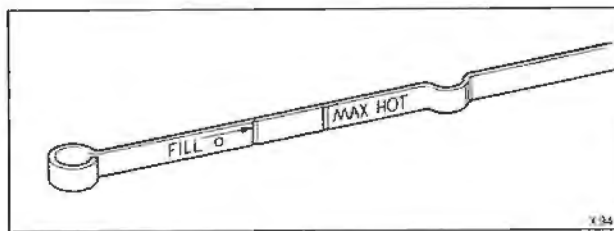
Fig. 2
Revised dipstick
