## **Service Bulletins**

**Rolls-Royce Silver Cloud II**  
**Rolls-Royce Silver Cloud III**  
**Bentley S2**  
**Bentley S3**  
**Phantom V**

SERVICE INFORMATION FOR THE ROLLS-ROYCE SILVER CLOUD III  
AND BENTLEY S. 3.

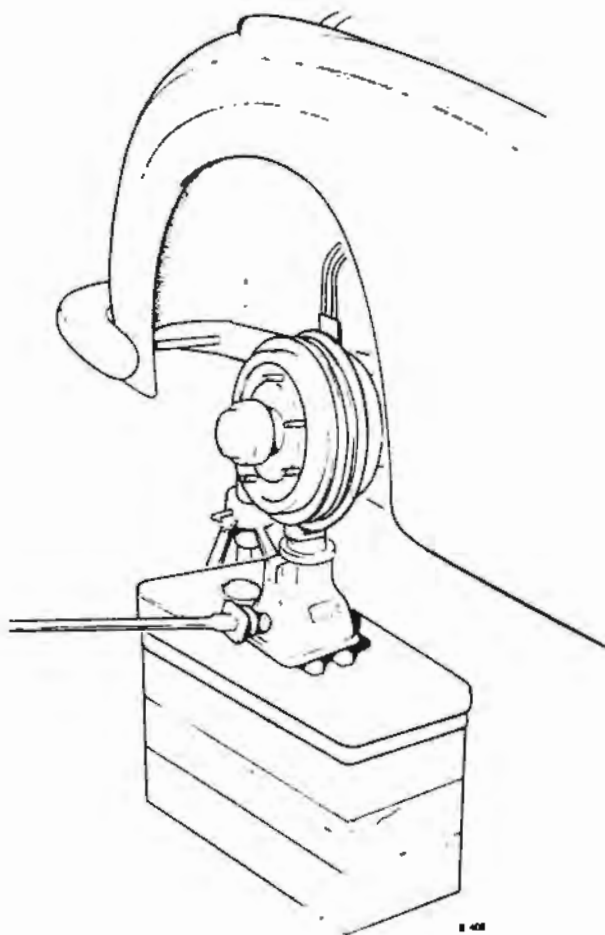
Fig. 2. Method of Measuring Front Suspension Friction.

The friction should be measured after each of the following operations until a figure is obtained not exceeding 36 lb. If the friction is reduced by any one of the operations it should be noticeable by raising the suspension by hand.

1. Slacken the two  $\frac{1}{2}$  in. U.N.F. bolts securing the shock damper to the chassis frame; then re-tighten them.
2. Slacken the two bolts securing the shock damper mounting plate to the chassis frame; then re-tighten them.
3. Slacken all four bolts securing the shock damper, then remove the rear two bolts, nuts and washers. Tighten the two front  $\frac{1}{2}$  in. U.N.F. bolts first and then fit and tighten the rear two bolts. If the rear two bolts cannot be positioned in the mounting plate holes these holes should be enlarged by filing to obtain correct alignment.

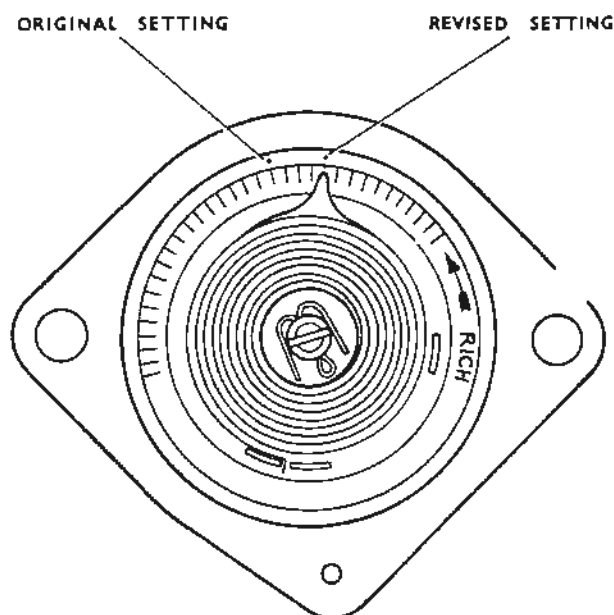
Fig. 3. Setting of bimetal coils

Because of this strong tension in the coils, a high temperature is required to keep the choke open, and when the car is stationary, the temperature around the coils cannot be maintained; this causes the choke to close and results in poor starting when the engine is warm.

Slacken the nut and bolt, securing the bimetal coils in position, then retard the pointer four divisions in a clockwise direction, thereby weakening the tension of the coils (see Fig. 3). Lock the bimetal coils in position and make a new centre 'pop' mark opposite the pointer. The old centre 'pop' marking should be peened over.

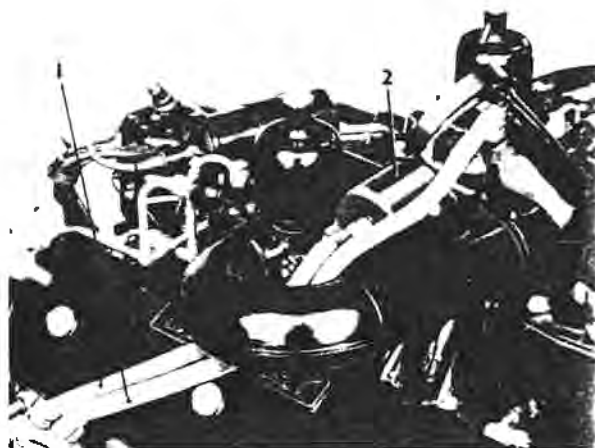
When driving a car for prolonged periods at high speed, there is a reduction in the flow of hot air through the bimetal coil heating system, due to low manifold depression and an increase in heat losses from the bimetal coils due to the underbonnet air flow, with the result that the high temperature cannot be maintained and the choke tends to close. To overcome this fault, a cover shield must be fitted to the bimetal coil housing and the two choke hot air pipes must be replaced by pipes that are lagged with plaited asbestos sleeving. (See Fig. 4.).

Engine fitted with heat shield and asbestos lagged hot air pipes

Remove the existing choke hot air pipes from the 'A' Bank exhaust manifold and the butterfly housing, then replace them with two pipes UE.8232 and UE.8233, which are lagged with plaited asbestos sleeving. Pipe UE.8232 fits between the exhaust manifold and the coil housing and pipe UE.8233 fits between the exhaust manifold and the butterfly housing.

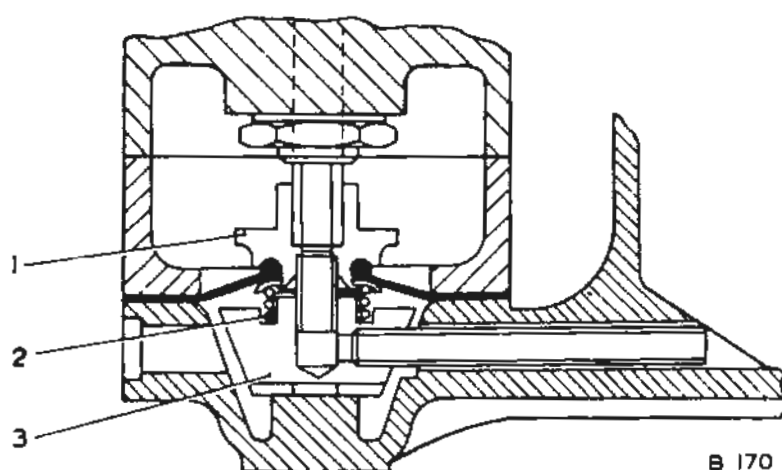
Fig. 1. Section of Carburetter Jet Well.

Some isolated cases of poor hot starting have occurred due to vaporisation of fuel in the carburetter jet wells. To remedy this fault, it has been found necessary to replace the existing jet assemblies with modified parts

Fit the nylon plug and tube assembly (CD. 1864) into the base of the main jet well as shown in Figure 1.

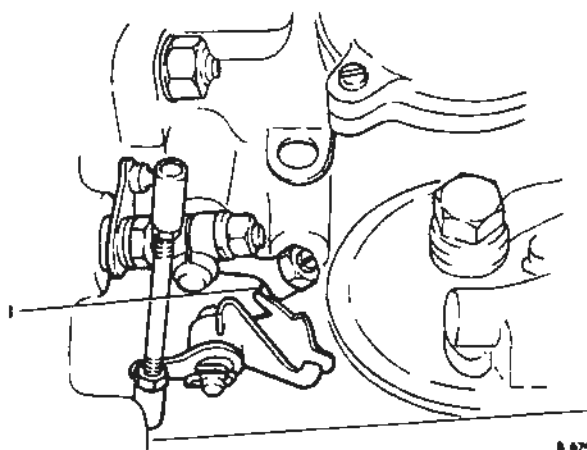
**Fig. 1. Two Step Fast-Idle Cam**  
**1 Position for setting fast-idle speed at 600 r.p.m.**

Fit the new fast-idle cam (UE.9451) to the spindle and check that it is free to rotate. The cam should be fitted so that the thin, tapered end is over the stop peg on the spindle bracket.

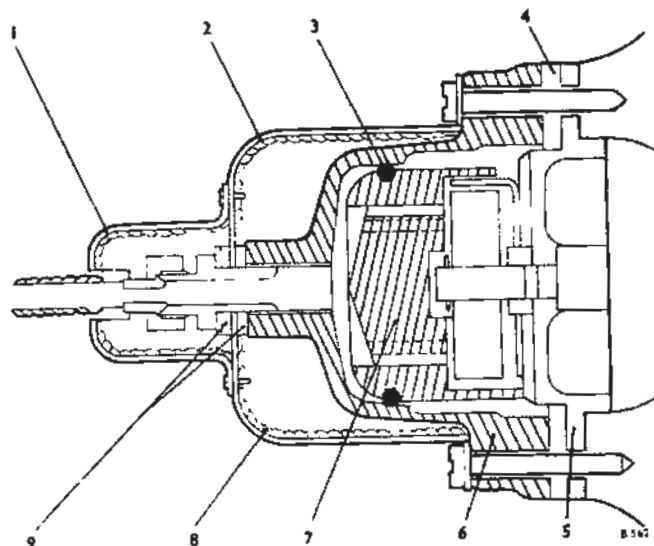
Fig.1. Sectioned View of Heat-Sink.

The main purpose of the heat sink modification is to improve initial cold drive-away and to prevent the choke closing under hard driving conditions and coming on too quickly after stopping.

Fit the coil housing and heat sink to the coil assembly. The two existing screws  
should be replaced by two longer ones (K.1928/Z).

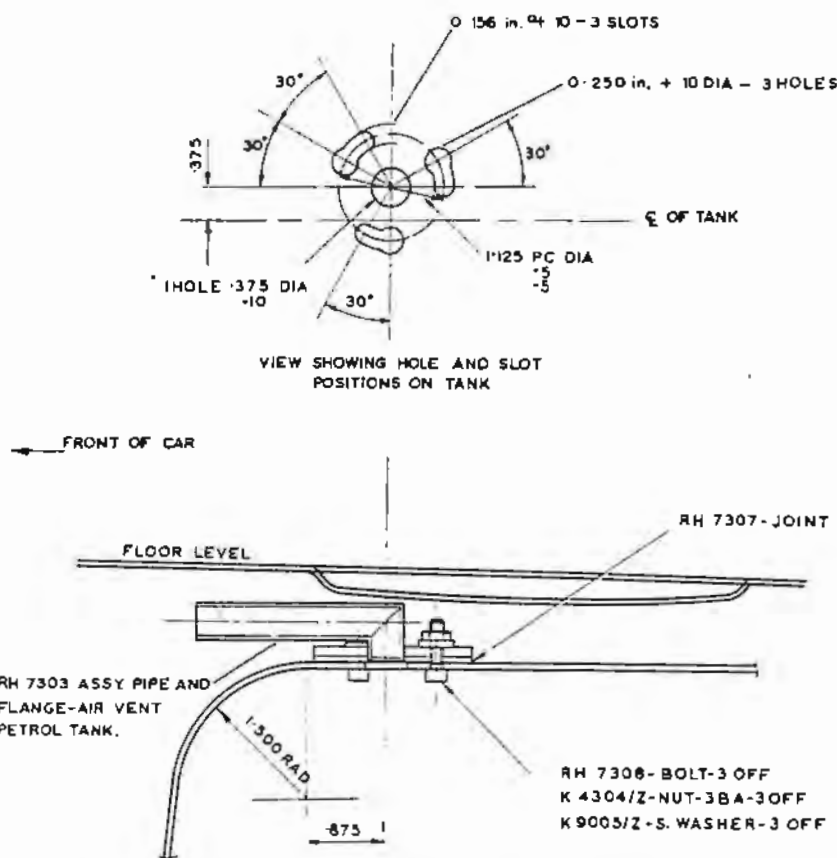
Fig.1. Dimensions for cutting slots in petrol tank.

Working to the dimensions given in Figure 1, drill a hole 0.375 in. diameter in the top of the tank, then drill three further holes 0.250 in. diameter and produce the slots.

After drilling the holes and cutting the slots it is most important that the tank is thoroughly washed with paraffin to remove all dirt and swarf.

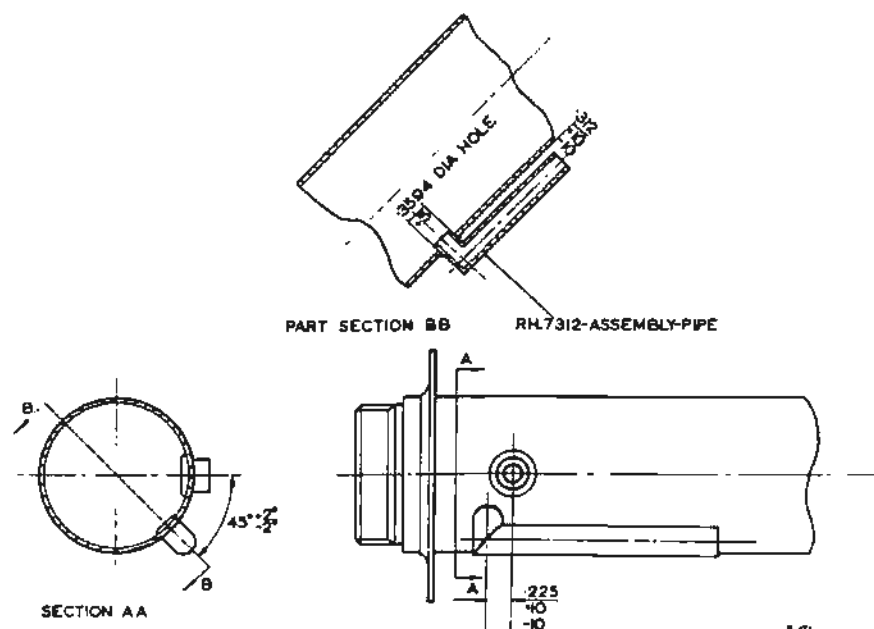
Fig.2. Dimensions for fitting vent pipe to filler tube.

Working to the dimensions given in Figure 2, drill a hole 0.359 in. diameter in the filler tube. Remove all burrs and sharp edges.

Locate the vent pipe (RH.7312) in the hole and 'low temperature braze' it into the filler tube.

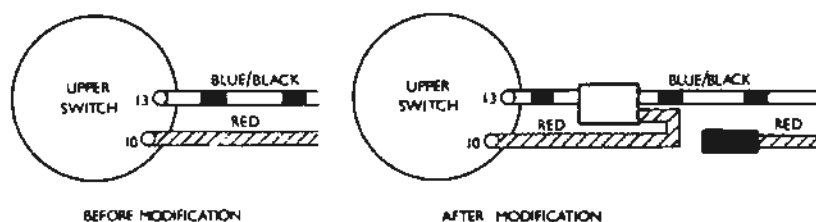
**Fig. 1 Modification of the wiring of the 'Upper' (Ventilation) Switch.**

Reconnect the blue/black wire to terminal 13 of the switch and connect the new red wire to terminal 10.

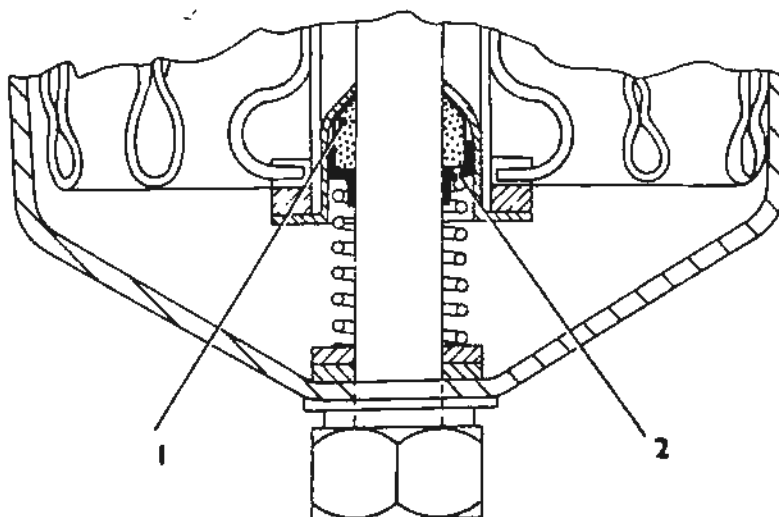
Failure to fit these washers, allows unfiltered oil to pass up the central tube of the filter and this can result in serious damage to the engine bearings.

Fig.1. Scrap view of oil filter showing position of washers

When servicing an oil filter, it is essential that particular care is taken to ensure that the cork washer is in a servicable condition and is fitted, together with the cup washer, in the correct position as shown in Figure 1.

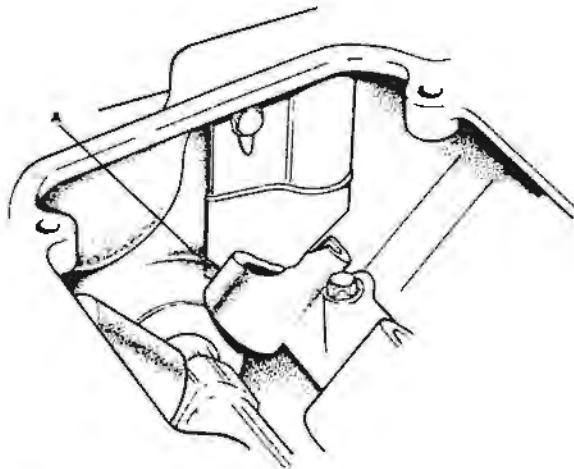
This is caused by the camshaft flinging oil through any gap which may exist between the breather baffle and the wall of the crankcase

Fig.1. Modified Baffle shown in position.  
'A' Area of Metal to be Removed

Remove the baffle plate and relieve the bottom edge to ensure that it clears the boss, formed by the camshaft bearing (see 'A' in Fig 1). Fit the baffle plate in position, and if necessary bend it to ensure that it fits flush against the wall of the crankcase.

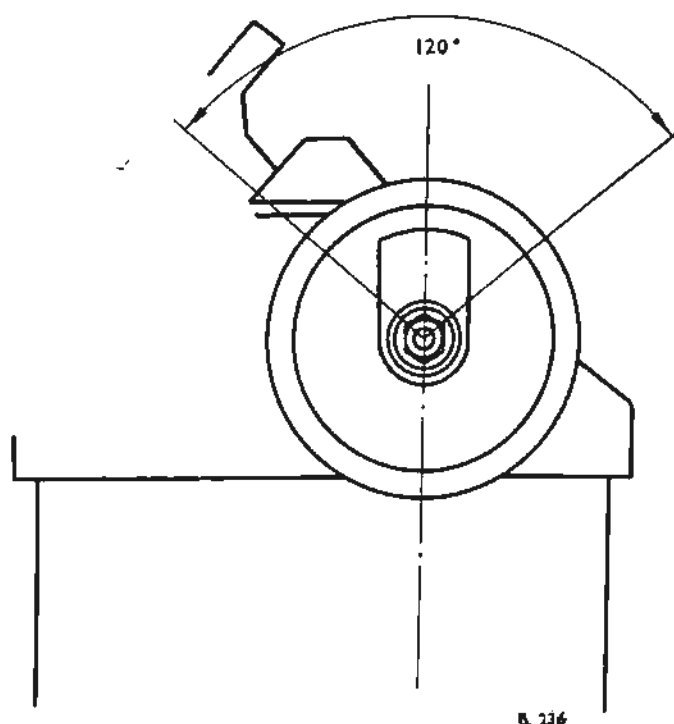
Fig.1. Position of the Oil Pressure Transmitter.

The correct position of the transmitter can be obtained by fitting additional copper washers to the threaded union.

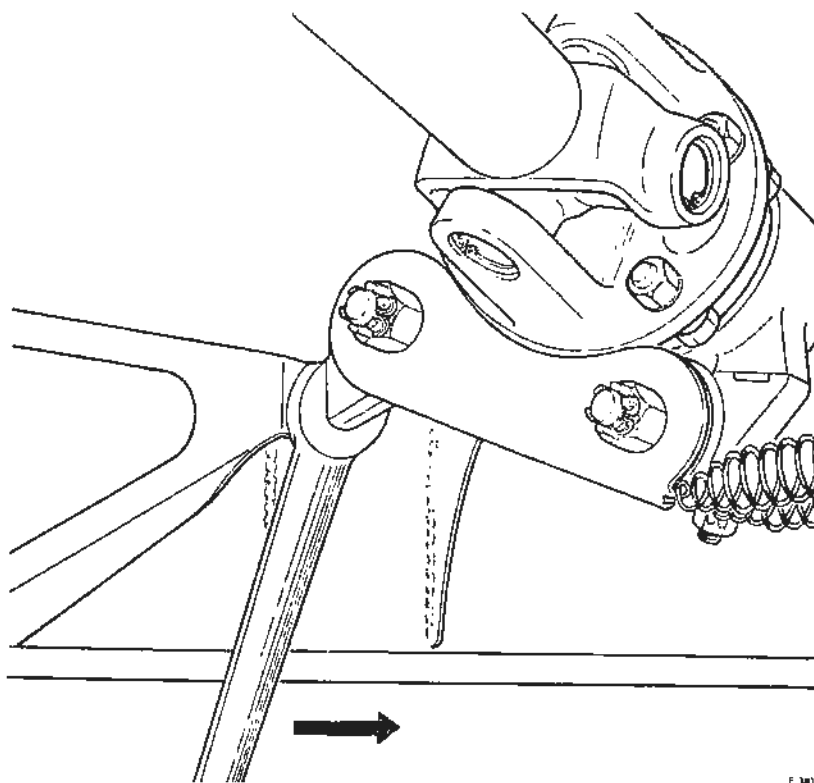
Fig.1 Anti-squeal setting of the centre bearing housing

Using a  $\frac{3}{4}$  in. A/F open ended spanner, twist the centre bearing mount about its retaining bolt (see Fig.1) until all the clearance has been taken up in the bearing. This is a very delicate operation, and can be carried out as follows

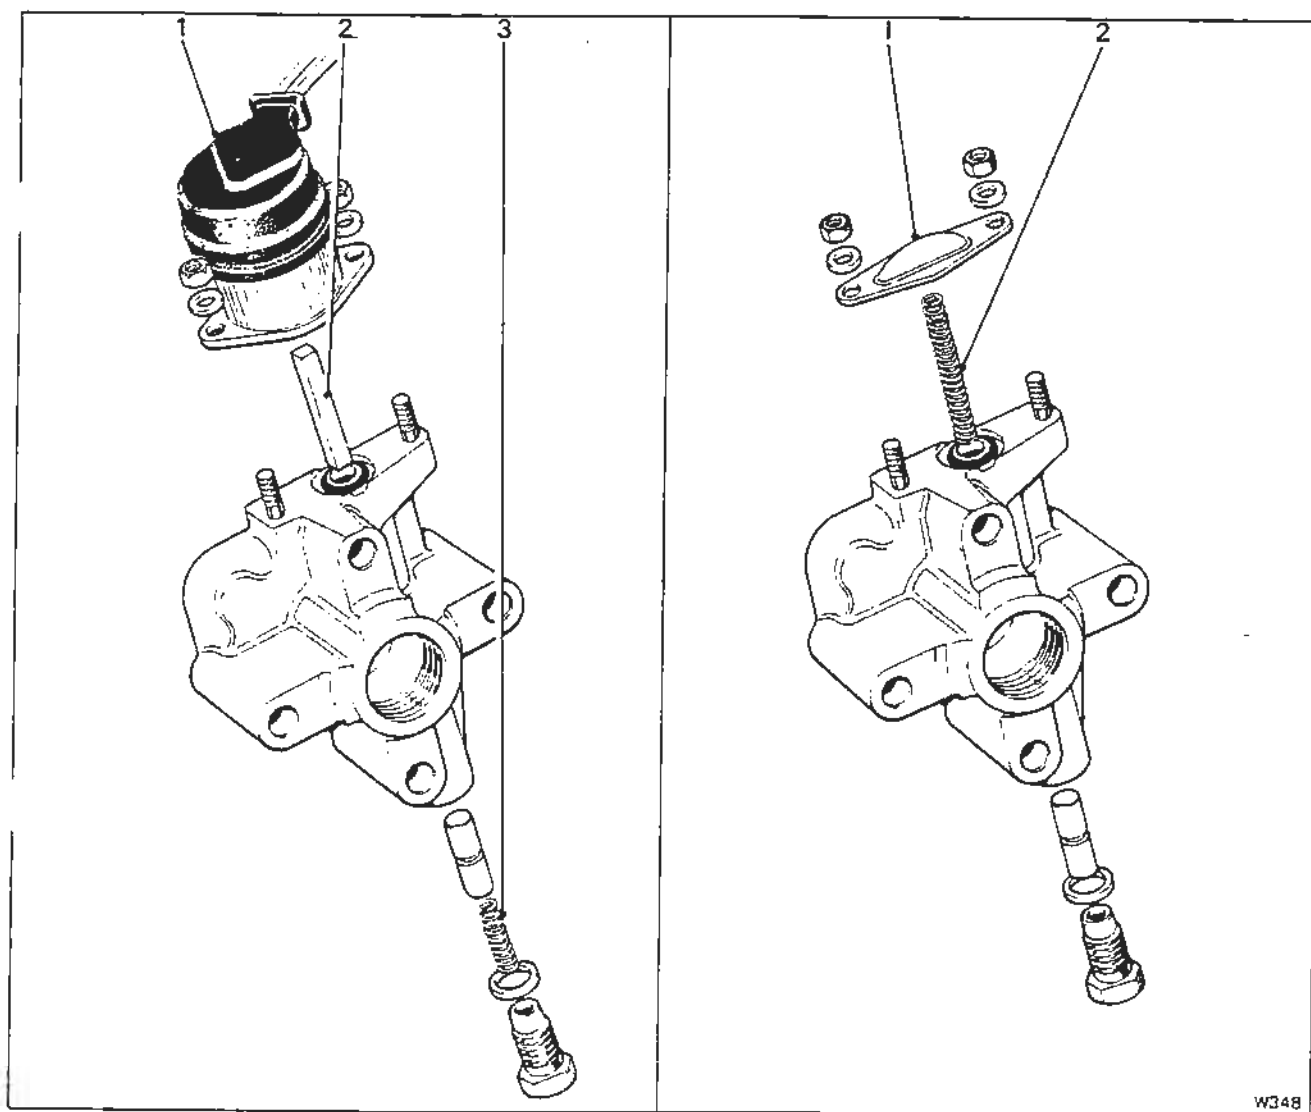
FIG. 1 EARLIER ASSEMBLY

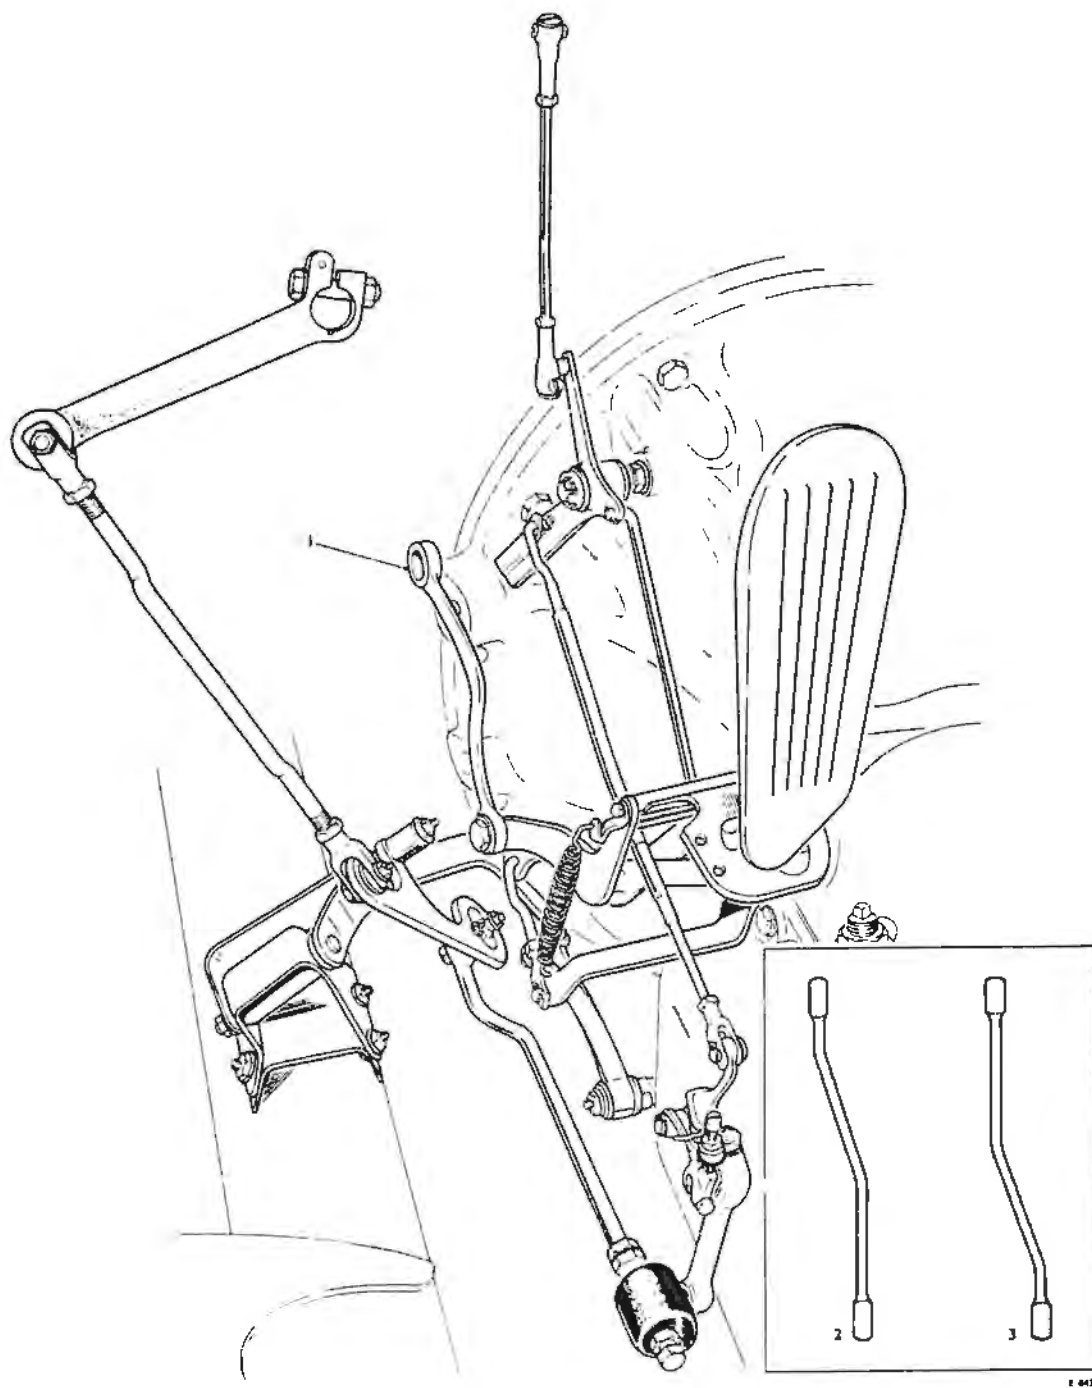
Fig.1 Correct position of the isolating link

1. Isolating link (UE 8090)
2. Correct view

The link must be fitted so that the forging number of the piece, faces away from the bell housing. In this position the longer straighter portion of the isolating link is towards the bottom as shown in Figure 1.

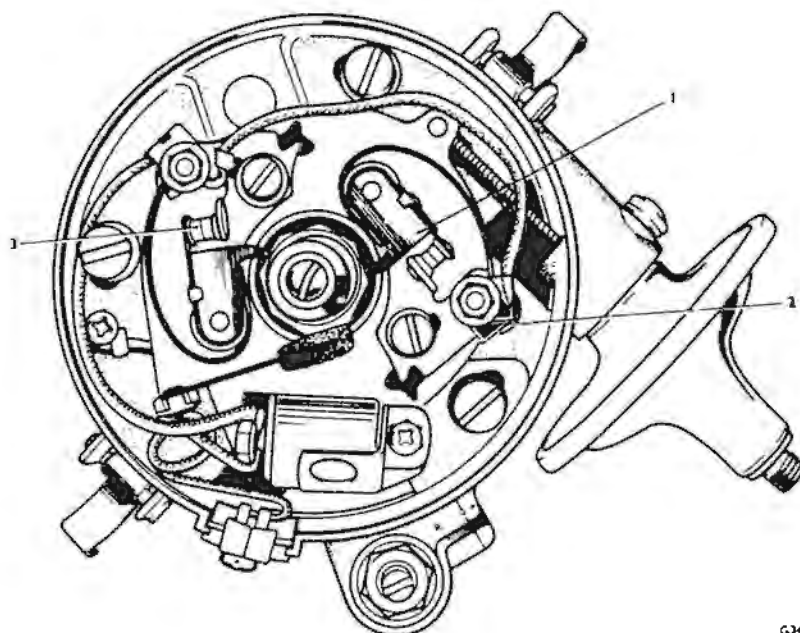
A trapped earth lead will not necessarily stop the car, but may cause the rotor arm to foul the segments within the distributor cap.

Fig.1 Internal view of distributor

- 1 Contact breaker points
- 2 Incorrectly positioned connecting wire tab
- 3 Contact breaker points

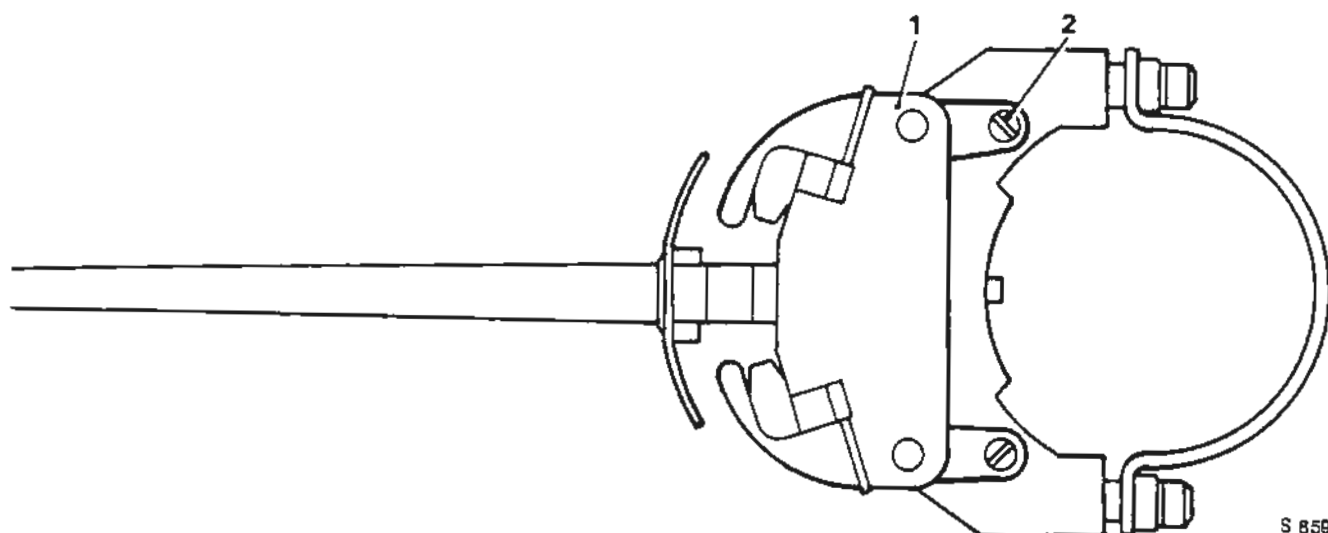
Figure 1. Direction indicator switch (UR 16530)

1. Insulation board
2. Screw

1. The removal and replacement procedure for the new switch remains the same as for the old. However, there is a small modification to be carried out on the new switch as follows:
2. Remove the two screws and discard the brown insulation board (see Fig. 1). Replace the screws with a washer (X 4401) behind each screw head (see Fig 2).
3. Cut the 7 pin plug off and withdraw the insulation board along with the green/yellow and green/blue wires.
4. Fit 'Lucar' connectors to all the wires except the black one to which a bullet connector is fixed. Connect the wires as follows.

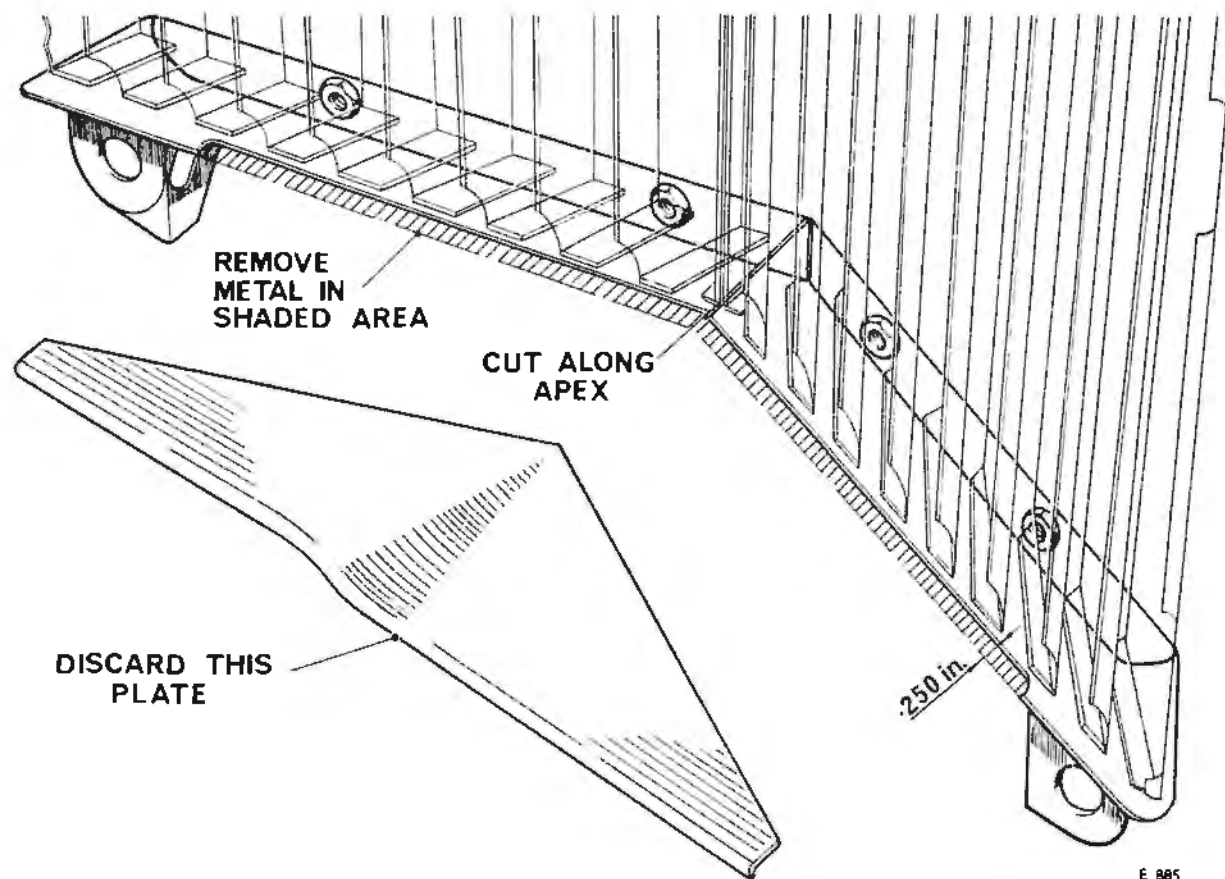
Fig.1 Modified radiator shutter assembly

The 'moan' which can be heard from within the car, always occurs when driving at speeds of between 34-38 m.p.h. and 40-50 m.p.h. during cold weather conditions. Extensive road testing by factory personnel located the source of the 'moan' to the radiator shutter assembly. The cause was later attributed to the assembly being too rigid thus allowing it to vibrate at a frequency within the audible range.

To eliminate the 'moan', the stiffness of the whole vane assembly was reduced so that its natural frequency of vibration was lowered sufficiently to take it outside the audible range. This was achieved by discarding the triangular shaped blanking plate which is spot welded onto the horizontal flange of the vee shaped lower bearing strip and by removing 0.250 in. from the rear side (i.e. spot welded area) of the lower bearing strip. The strip was then cut into two equal lengths by cutting along the apex of its vee form. For details of the modification see Figure 1.

- (1) Try to substantiate the customer's complaint if the prevailing weather conditions are as stated.
- (2) Remove the radiator shell.
- (3) Remove the vane assembly complete.
- (4) Carefully remove and discard the triangular shaped blanking plate from the vee shaped lower bearing strip onto which it is attached by means of spot welds.
- (5) Reduce the width of the horizontal flange of the lower bearing strip by removing metal from the area shown shaded (see Fig.1).
- (6) Cut the lower bearing strip along the apex of its vee form, thus producing two separate strips (see Fig.1).
- (7) Treat the exposed metal surfaces resulting from operations (5) and (6) with a suitable paint.
- (8) Refit the vane assembly.
- (9) Refit the radiator shell.
